# bibliotheca neolithica Asiae meridionalis et occidentalis

# BASTA II

## THE ARCHITECTURE AND STRATIGRAPHY

Hans Georg K. Gebel

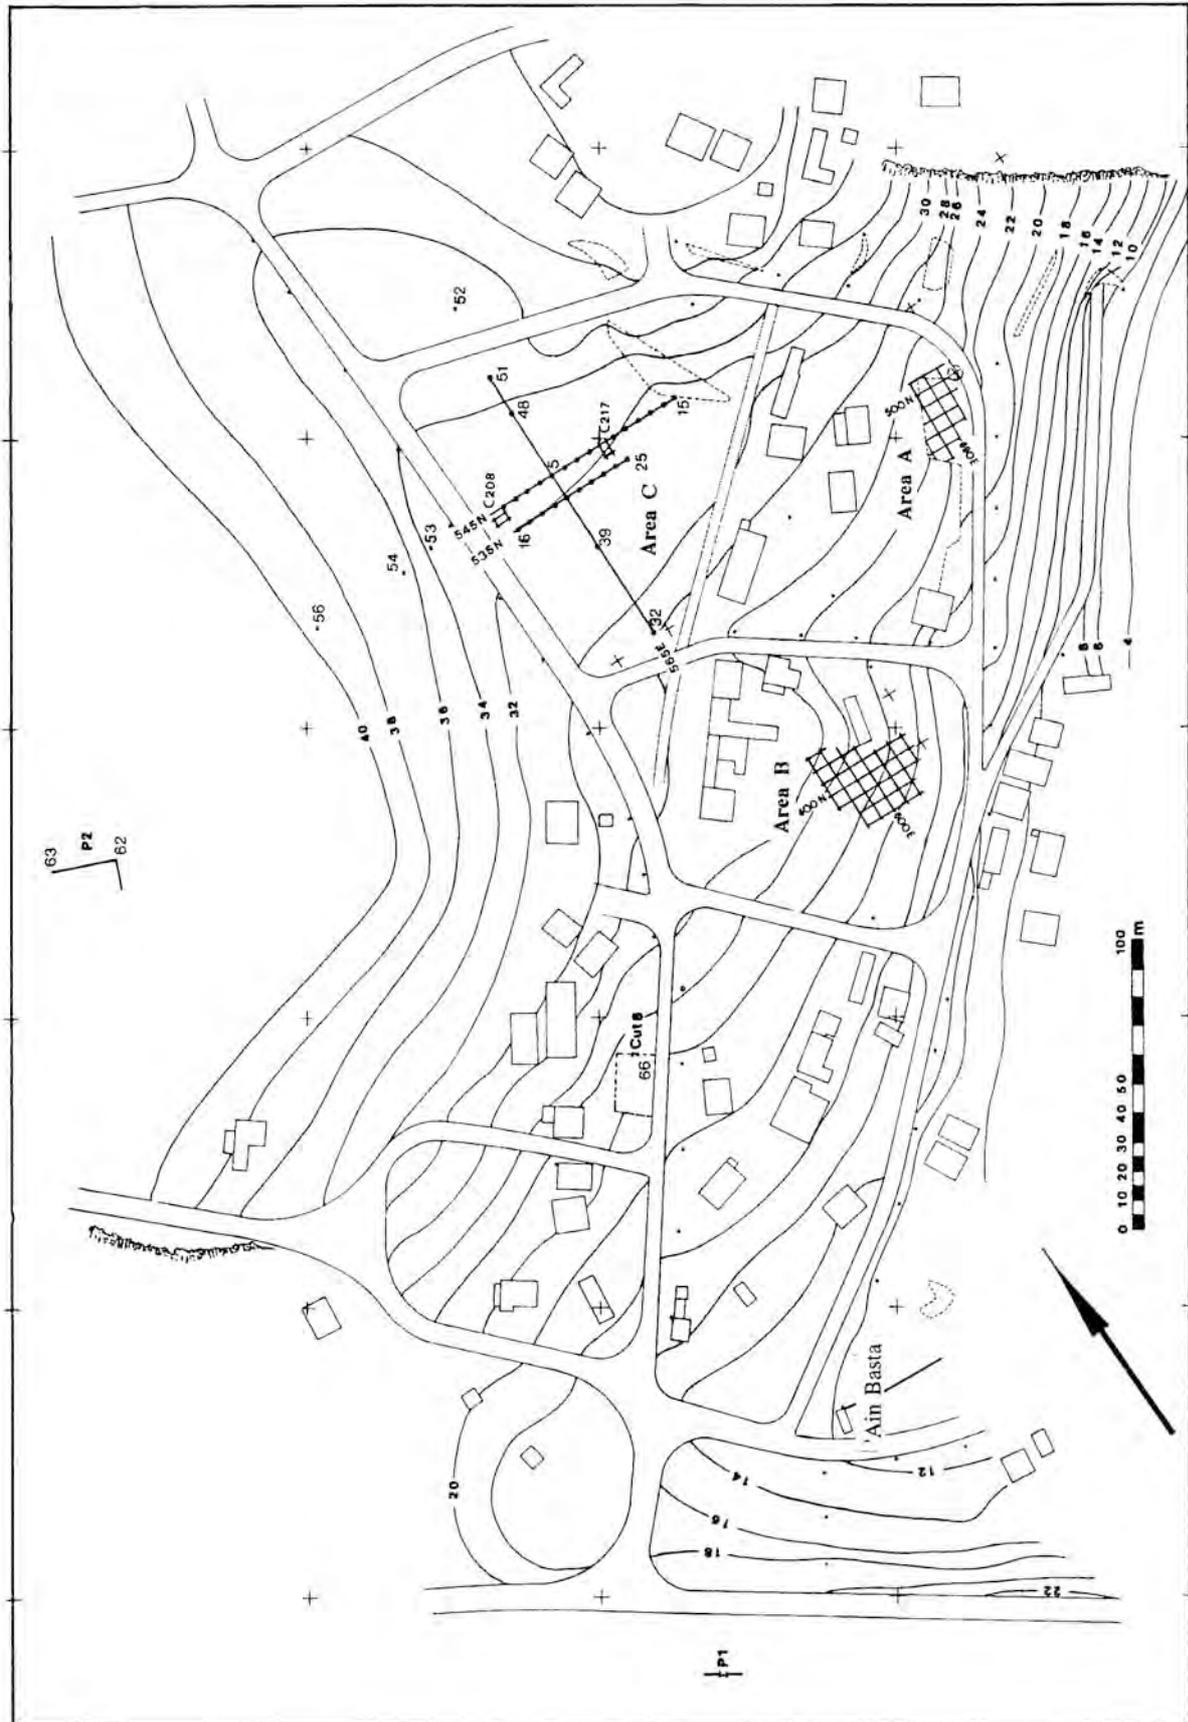
Fig. 3. Basta. Topographical map and areas of investigation (Kamp 2004: Fig. 1).

The decision regarding the archaeological potential hinged on the question of whether it was possible to find an undisturbed area for excavation in order to avoid any limitations posed by rescue work. Such an area was found almost in the centre of the new village, allowing a possible extension of the excavated area to up to 80 x 60 meters. Although located above the steep escarpment of the wadi, the area nevertheless had a gradient of only 6 m on 50 m towards the NW (Fig. 3). In addition to the favorable situation of the site, collection of surface finds revealed a dense coverage of Neolithic implements (Nissen, Muheisen, and Gebel 2004: 13, Fig. 4 and 14, Table 2), promising rich results below the surface. Designated as Area B this became our second main area of investigation (Fig. 3).

In spite of these thick alluvial layers we decided in 1988 to put two trial trenches of 2 x 4 m into this area (C 208 and C 217, *cf.* Fig. 3). As anticipated, hardly any architecture except some ephemeral stone settings was found, but we came across several Late PPNB cultural deposits, in two of which we found flint knapping locations, and a burial in another one.

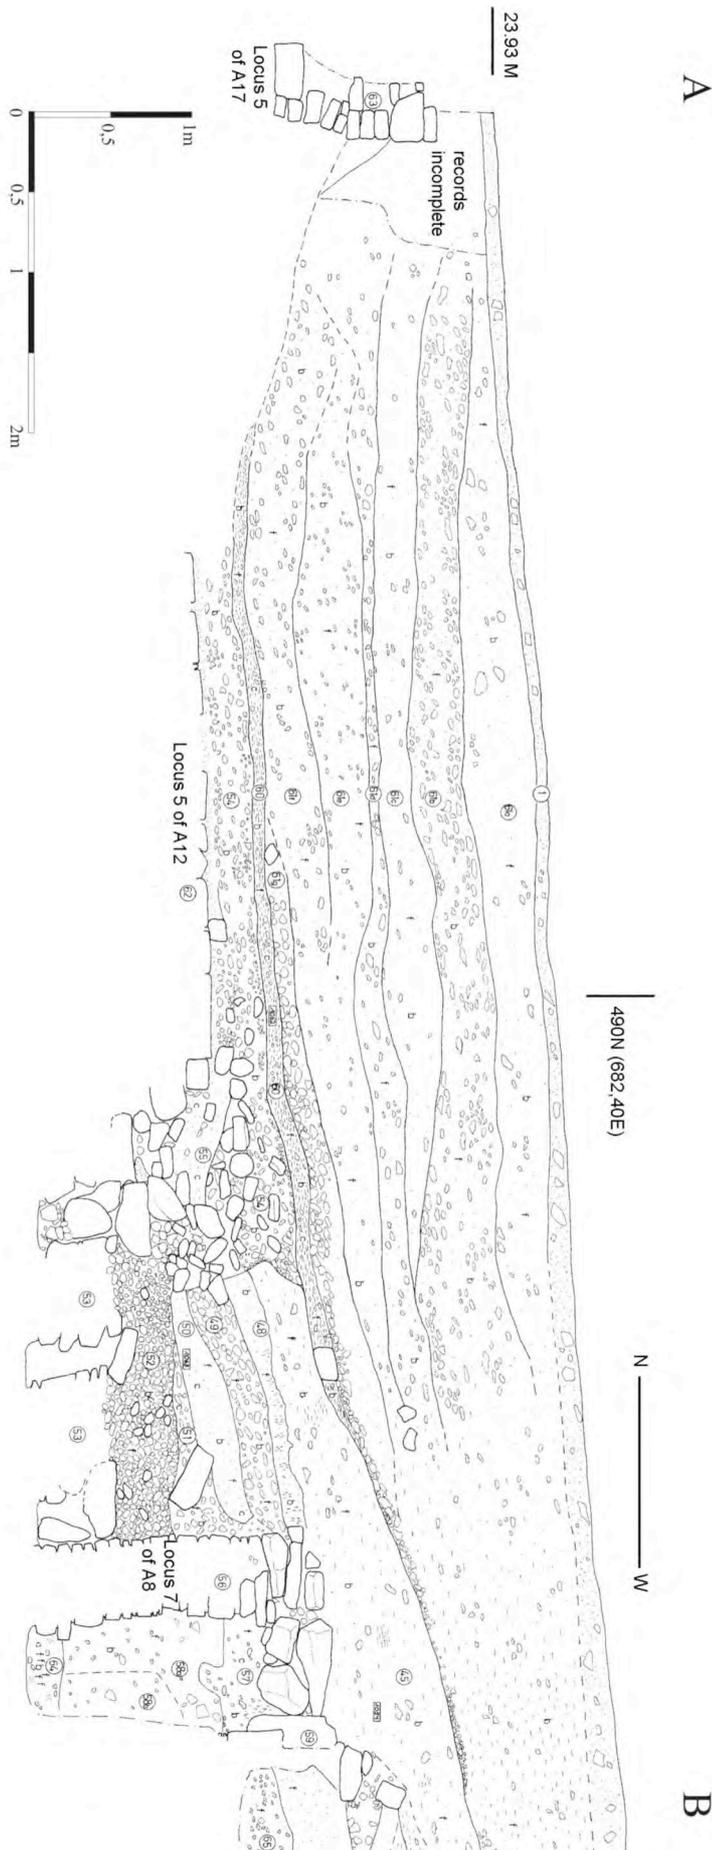
Fig. 2.A. Area A, NW Section, southern parts, 1986. Scale 1:40.

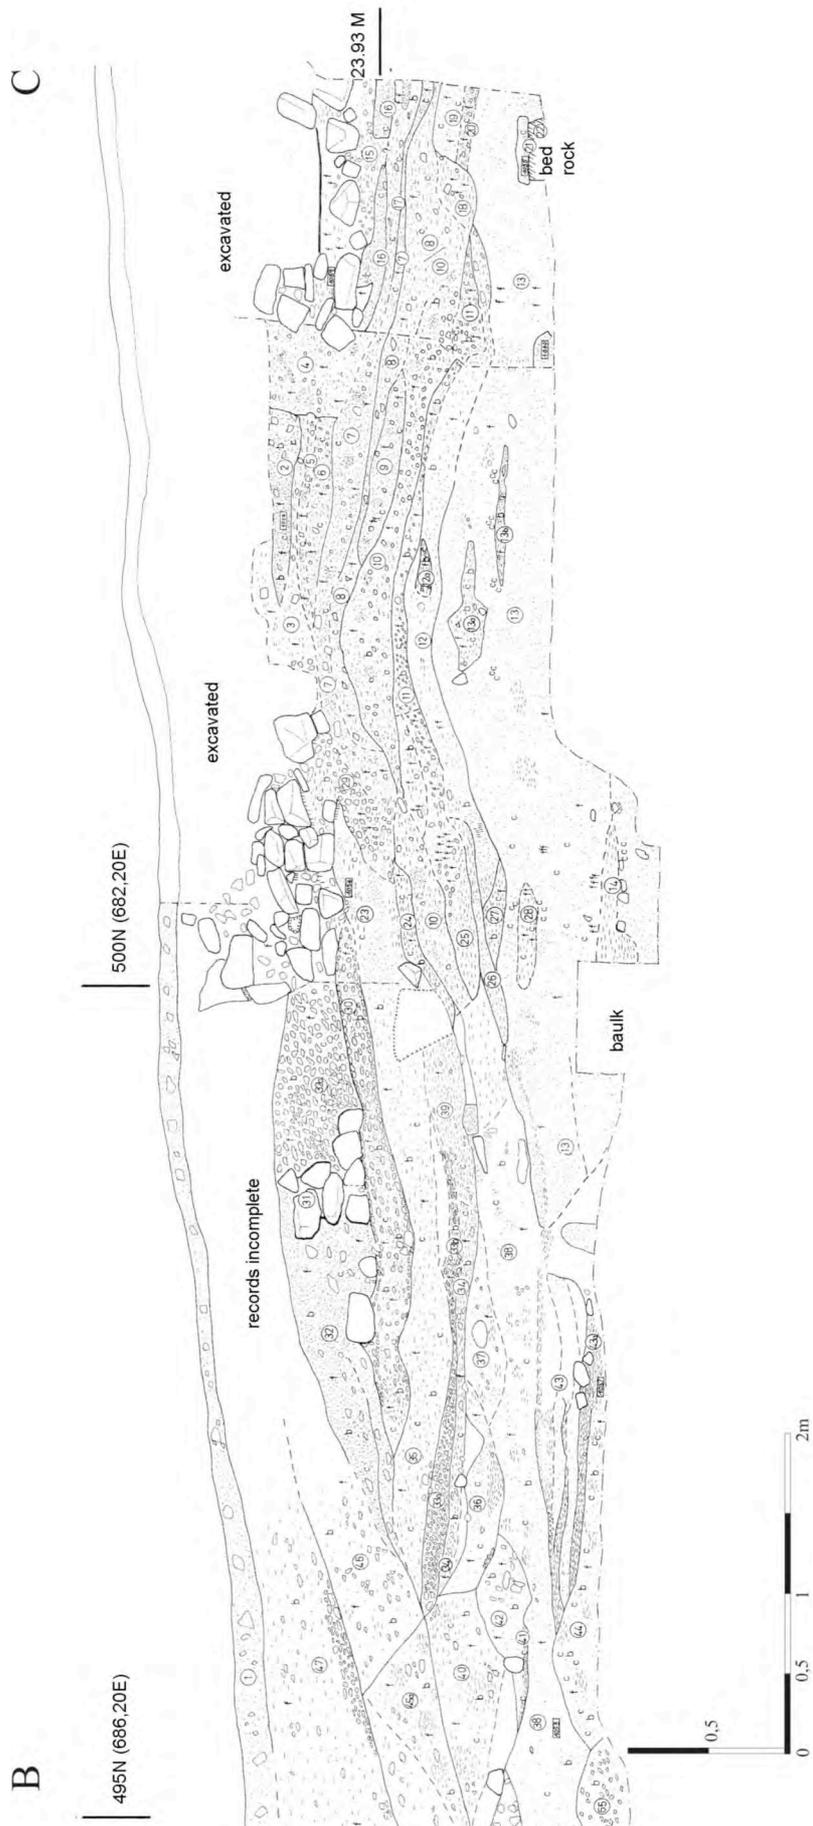
Fig. 2.B. Area A, NW Section. northern parts. 1986. Scale 1:40.

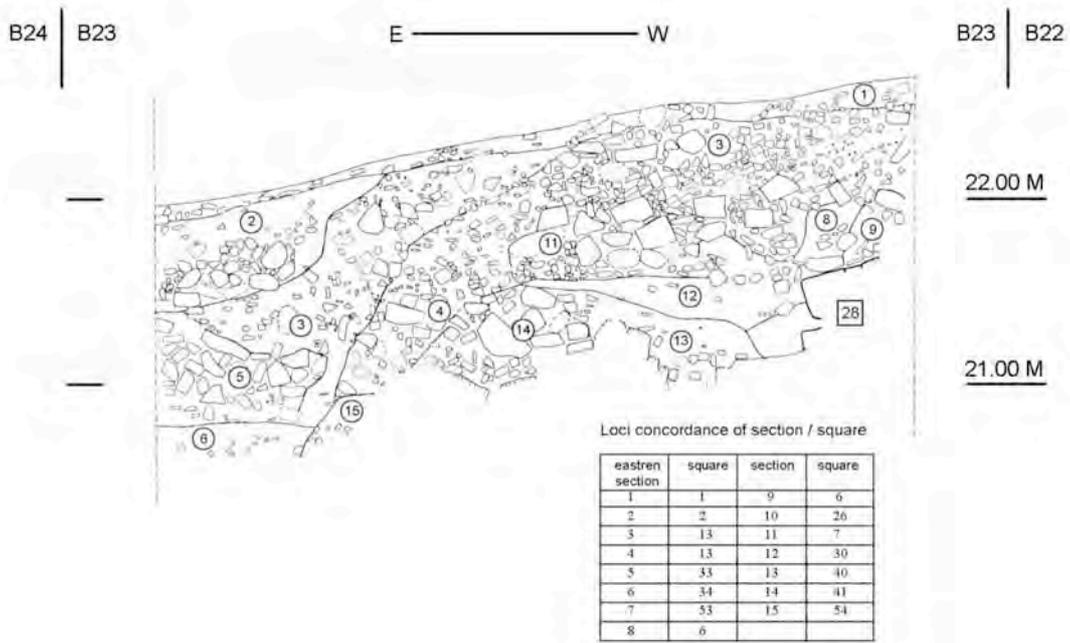
Fig. 3. Area B, Square B 23. Southern baulk section. 1989. Scale 1:40.

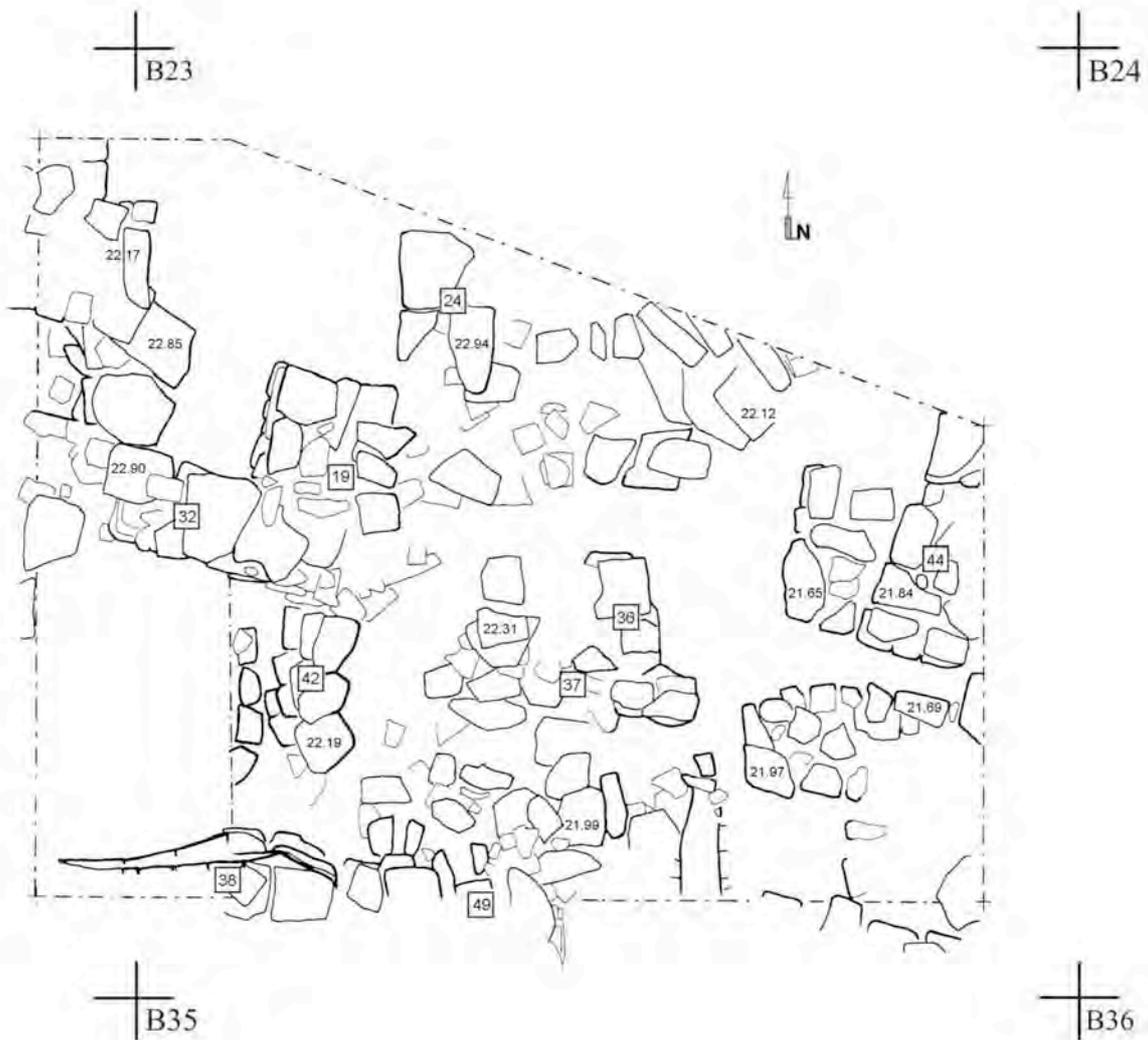
Fig. 4. Area B, Square B 23. Example of a disturbance zone between a recent pit and post-occupational room fills (e.g. collapsed walls fragments Loci 36 and 37). 1989. Scale 1:40.

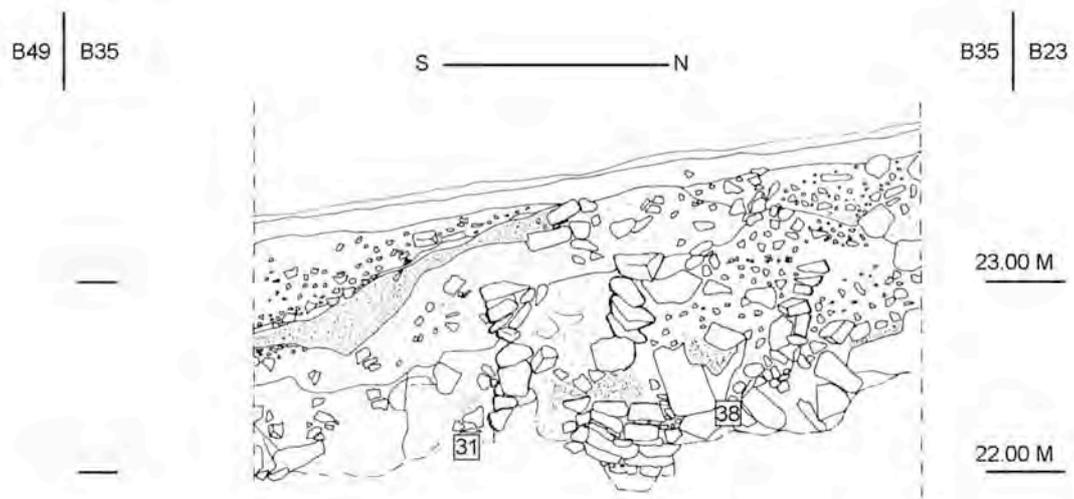
Fig. 5. Area B, Square B 35. Western baulk section. Example of an intact sub-surface evidence of dilapidated wall faces and roof ceilings. 1989. Scale 1:40.

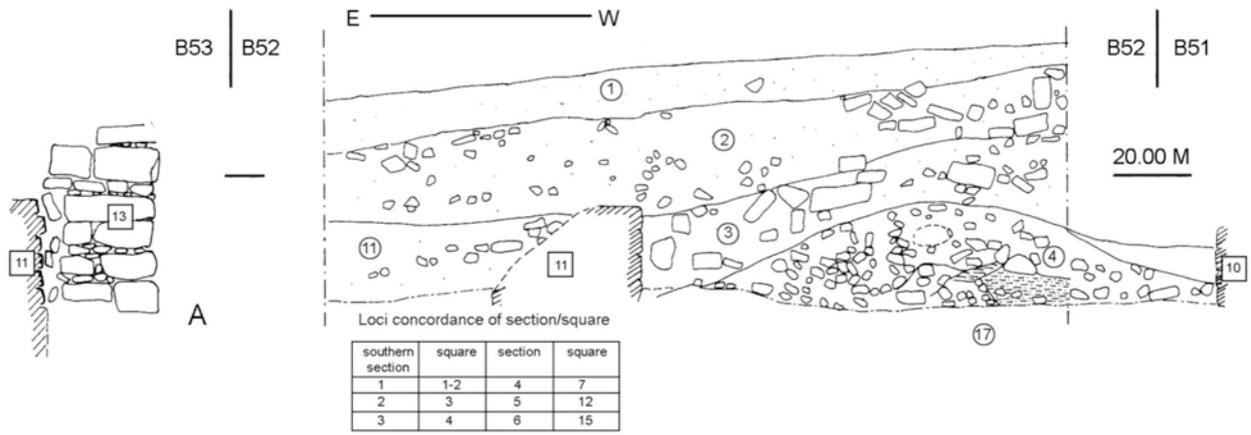
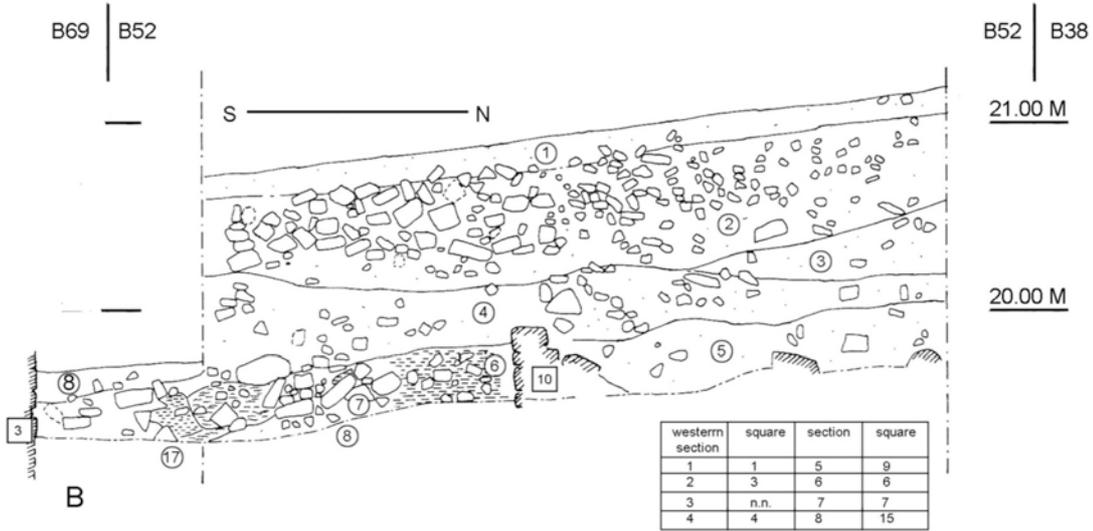
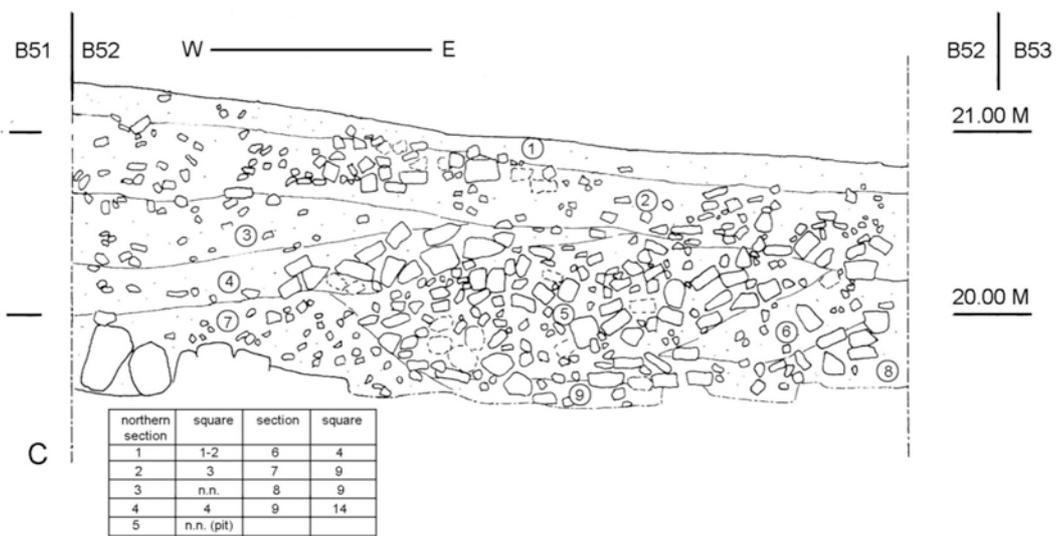
Fig. 6. Area B, Square B 52. Upper section stratigraphies of the southern (A), western (B), and northern (C) baulks; top left: face of buttress Locus 13. 1988. Scale 1:40.

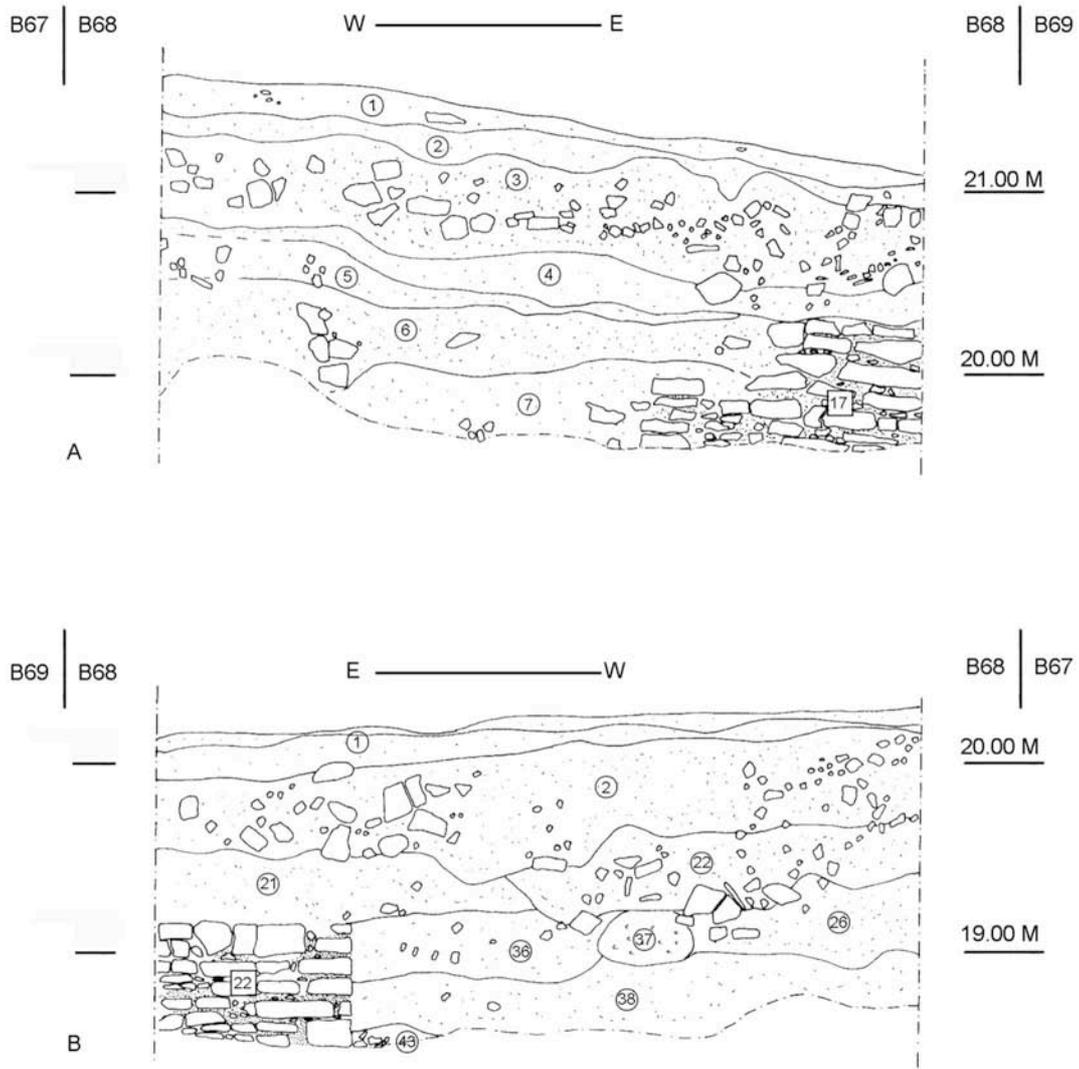
Fig. 7. Area B, Square B 68. Upper section stratigraphies of the northern (A) and southern (B) baulks. 1987. Scale 1:40.

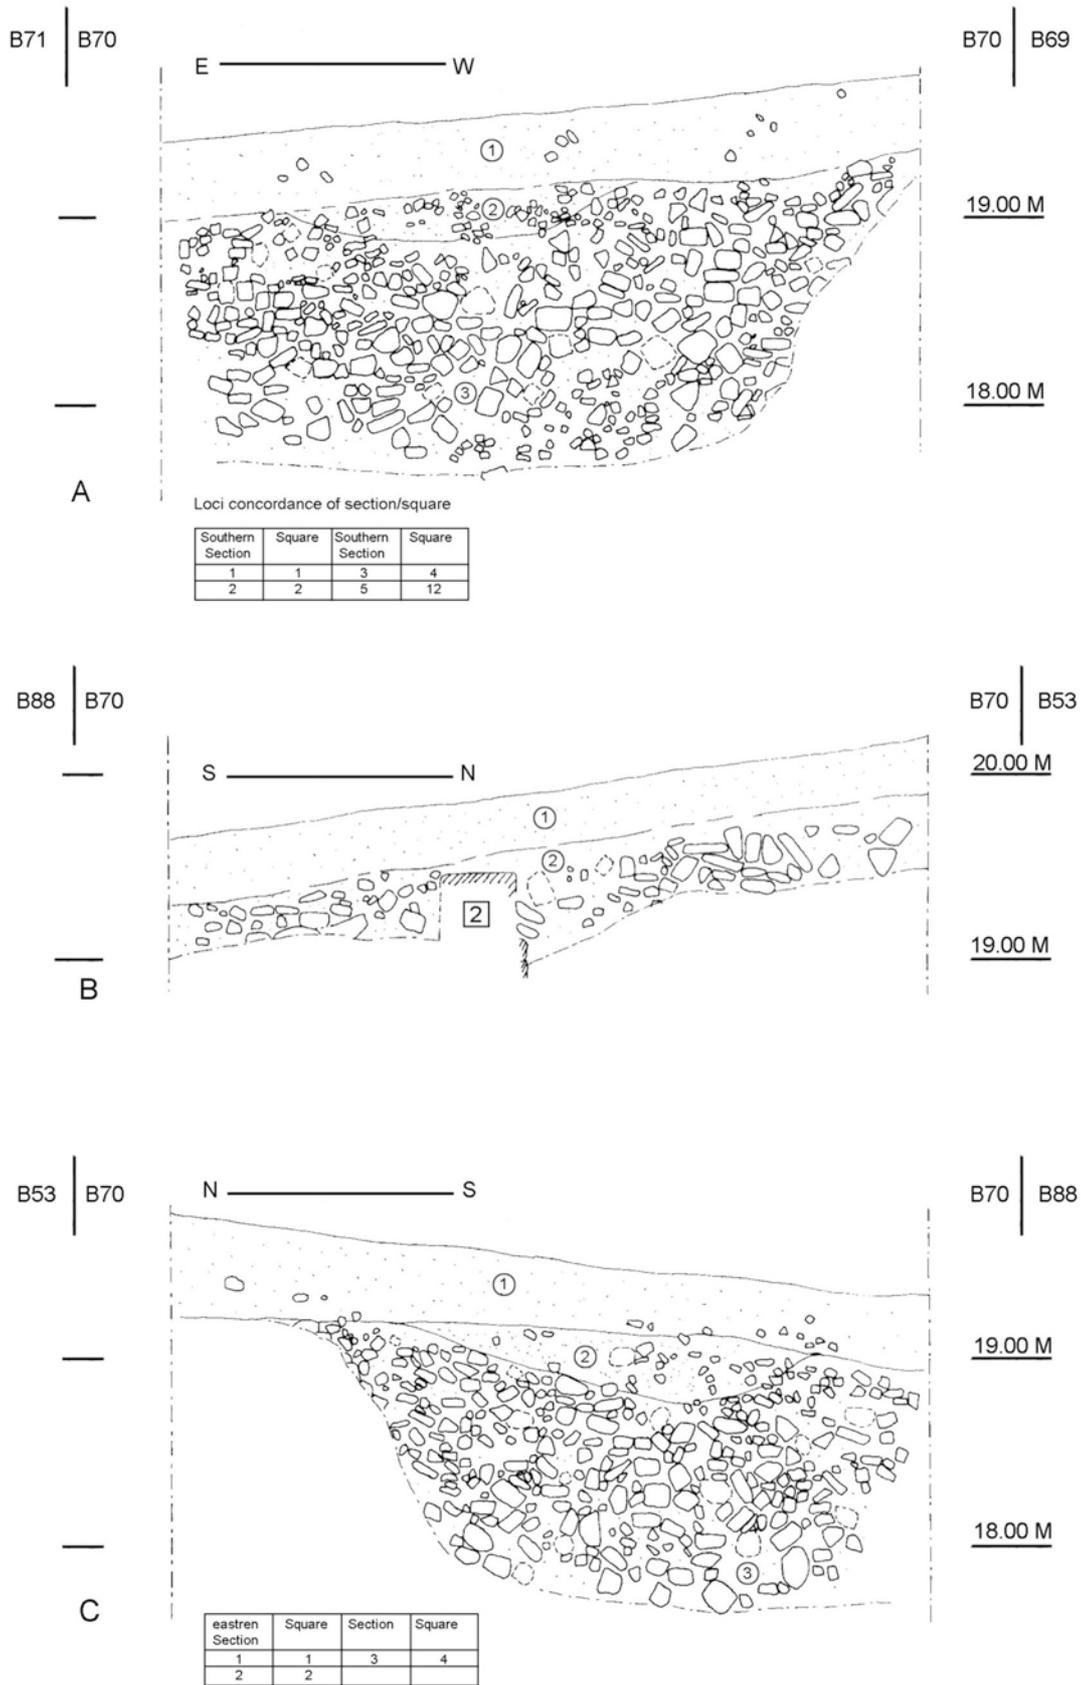
Fig. 8. Area B, Square B 70. Upper section stratigraphies of the southern (A), western (B), and eastern (C) baulks.

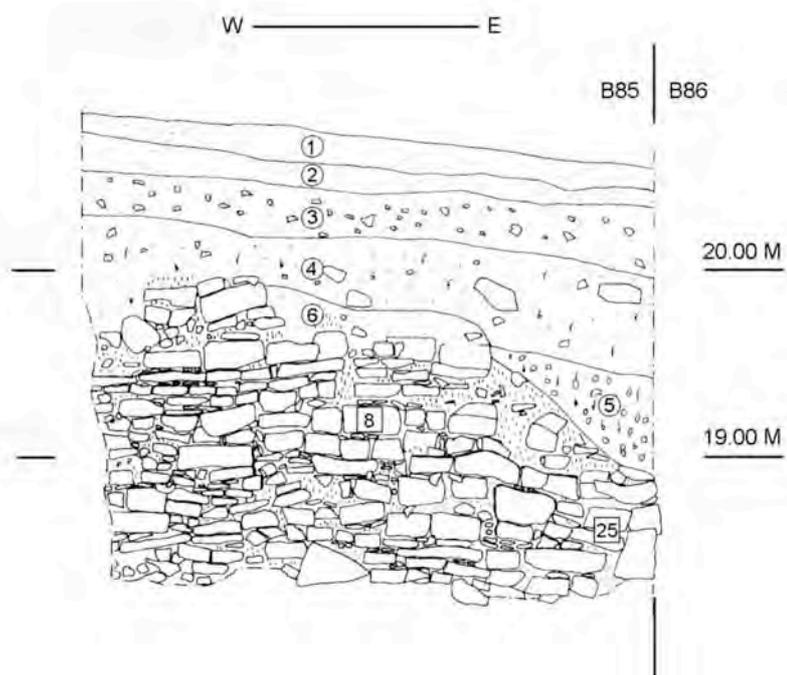
Fig. 9. Area B, Square B 85. View of Phase BII Walls [8] and [25], running out of the northern section of the square. 1989. Scale 1:40.

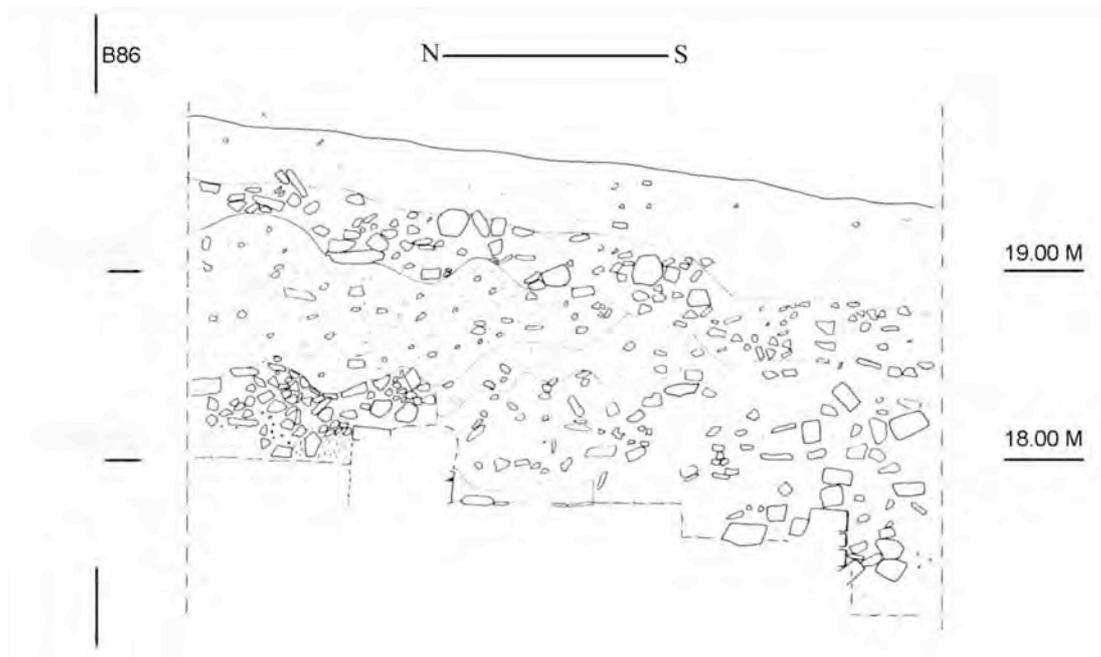
Fig. 10. Area B, Square B 86. Upper section stratigraphy of the eastern bank (above BII wall remains). 1987. Scale 1:40.

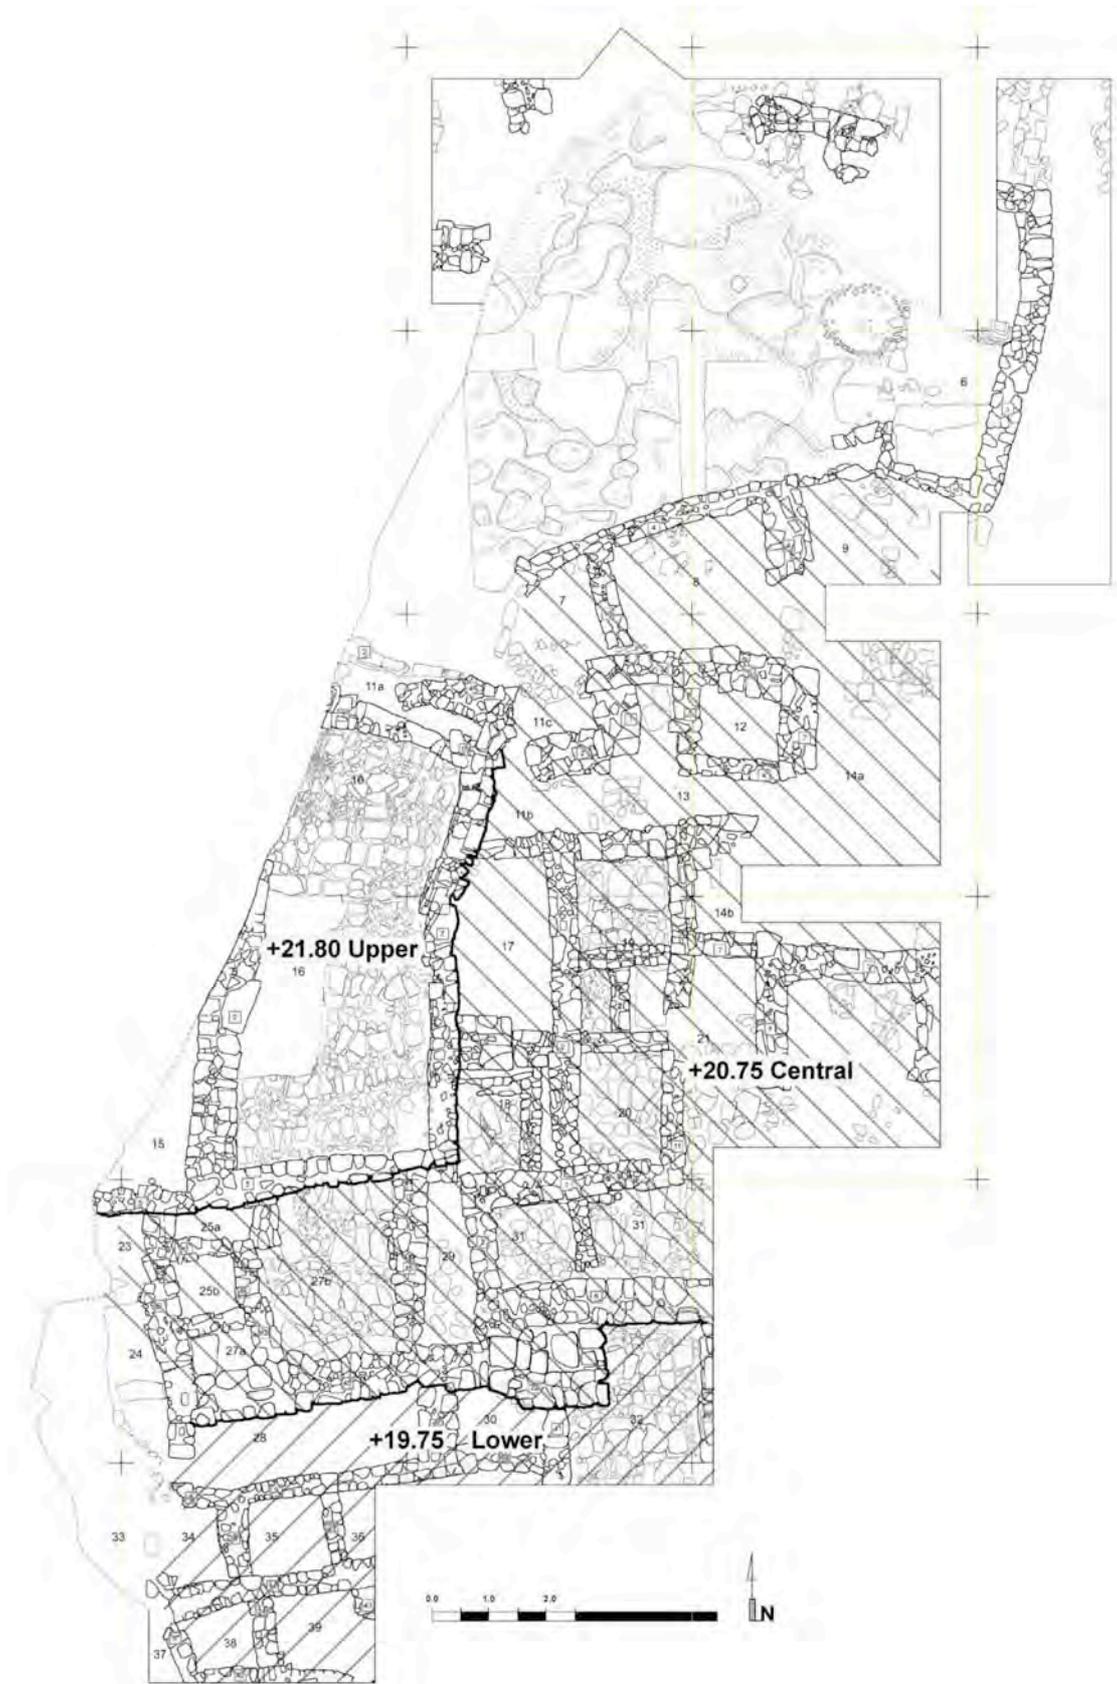
Fig. 1. Area A. Extension and elevation of the terraces of Phase AII.

The difference between the lower and the central terrace is 100 cms, between the central and upper terraces is 105 cms. Taking a distance of 7 m NW-SE between Rooms 16 and 32 as a baseline we find over this distance three steps with a total difference of 205 cms during Phase AII, or a gradient of 29.2 cms in 1 meter. To be sure, this is almost twice as steep as the gradient found at the bottom of the slope adjusting system in Squares A 13/18, but there is an easy and unsurprising explanation. It would be unusual to assume that the entire built-up area of an ancient settlement would be re-built at the same time, and thus rise at the same pace. Rather we have to assume that new buildings were erected in some places while in other places the old ones would continue to be inhabited. This is the case here, since the lower terrace without any doubt rests on a slope adjusting system, and therefore belongs to the earliest building phase of AIII. As far as we

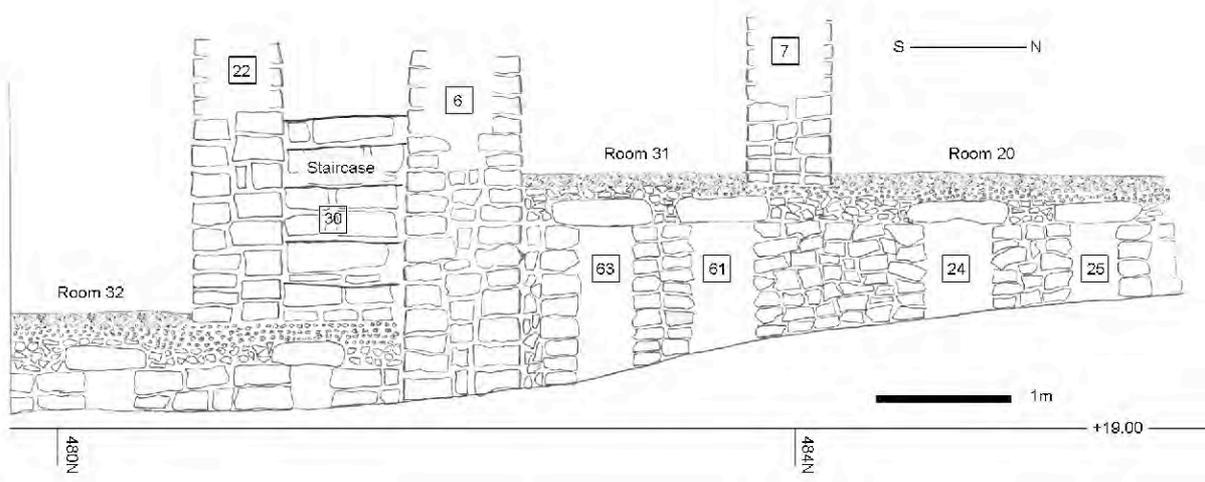
Fig. 3. Area A. Area A. Extension and elevation of the terraces on Phase AIII.

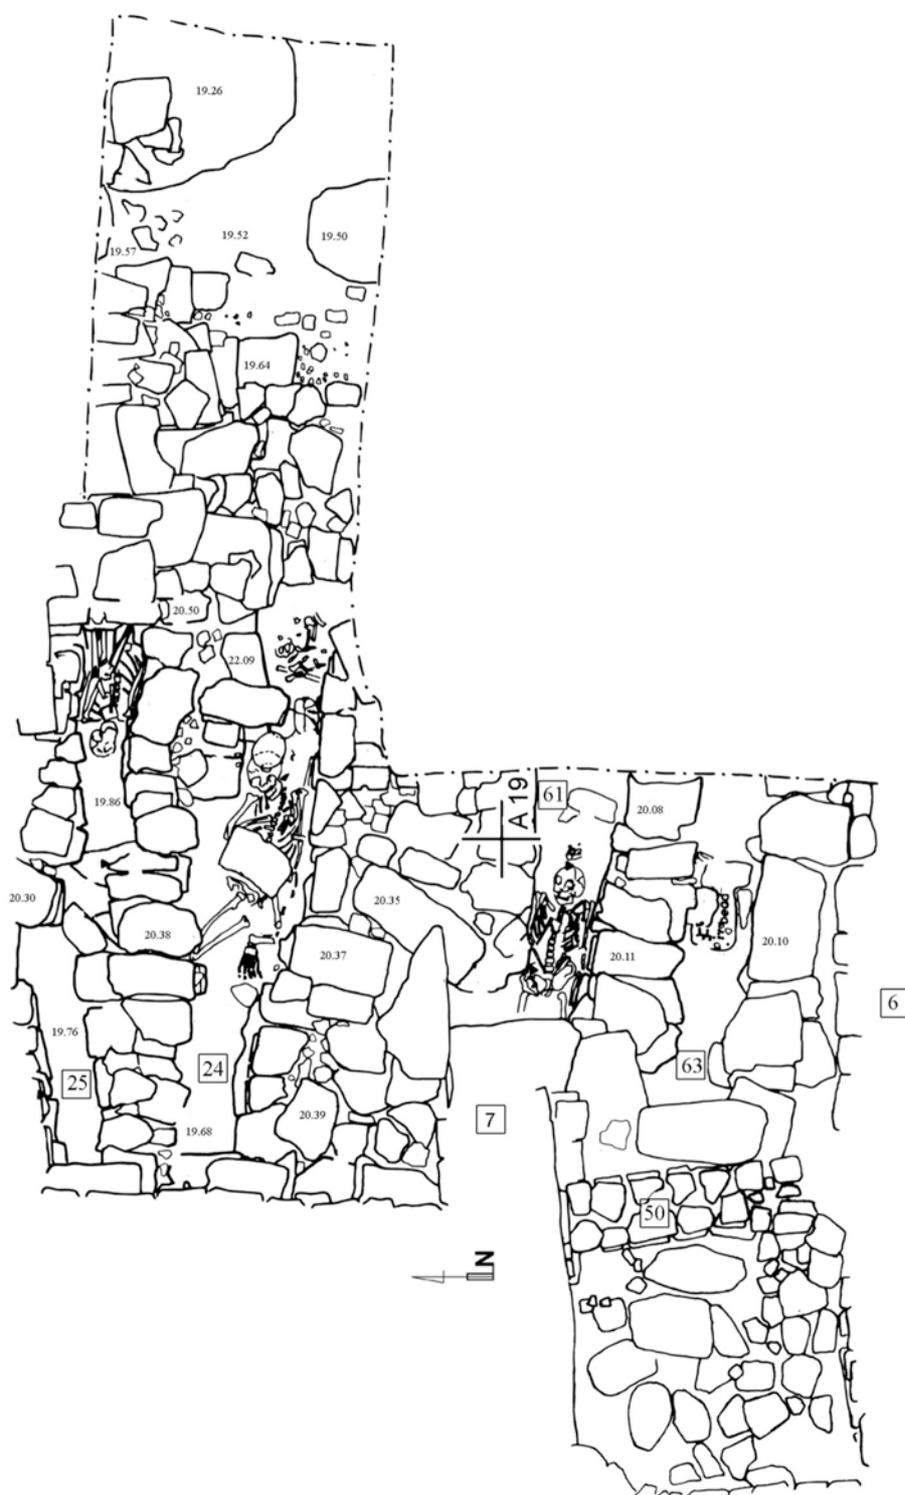
Fig. 4. Area A. Sub-floor channel system beneath Rooms 20 and 21, covering slabs partly removed exposing the channels containing human burials. Scale 1:40.

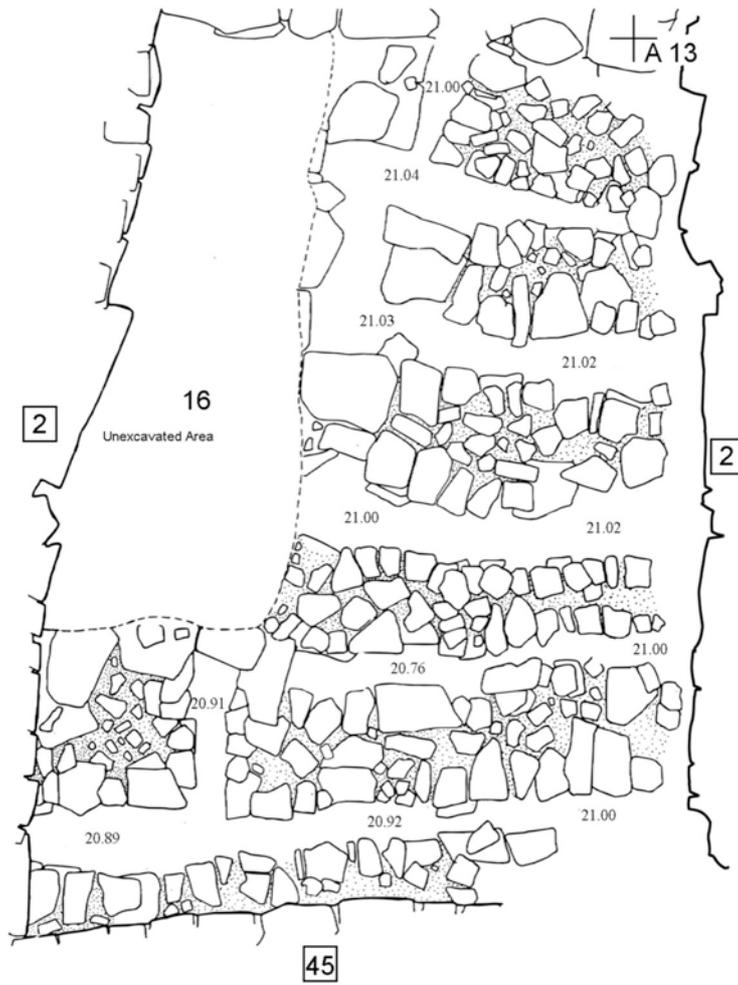
Fig. 11. Area A. Sub-floor channel system beneath Room 16, covering slabs removed, exposing the channels. Scale 1:40.

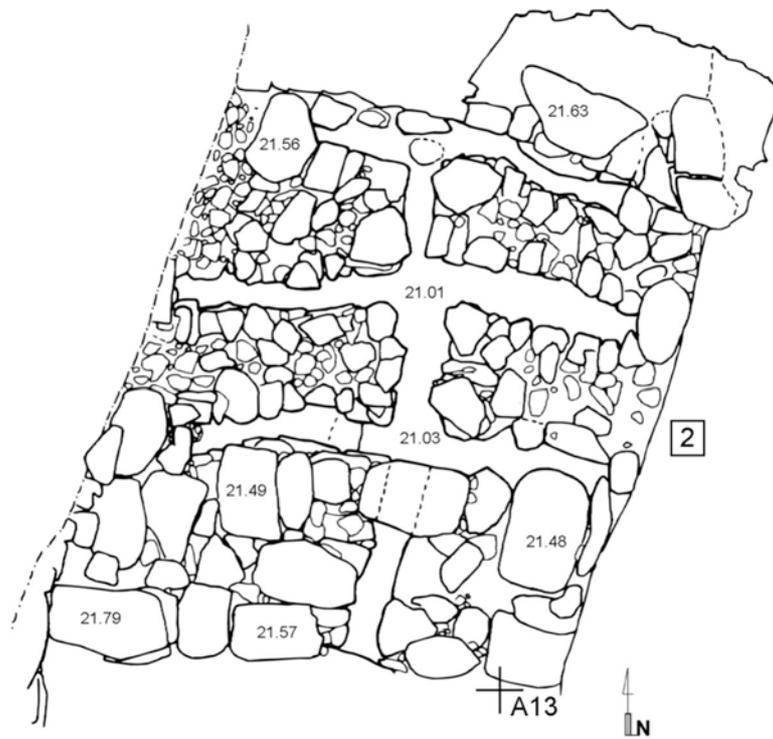
Fig. 12. Area A. Sub-floor channel system beneath Room 10, covering slabs removed, exposing the channels. Scale 1:40.

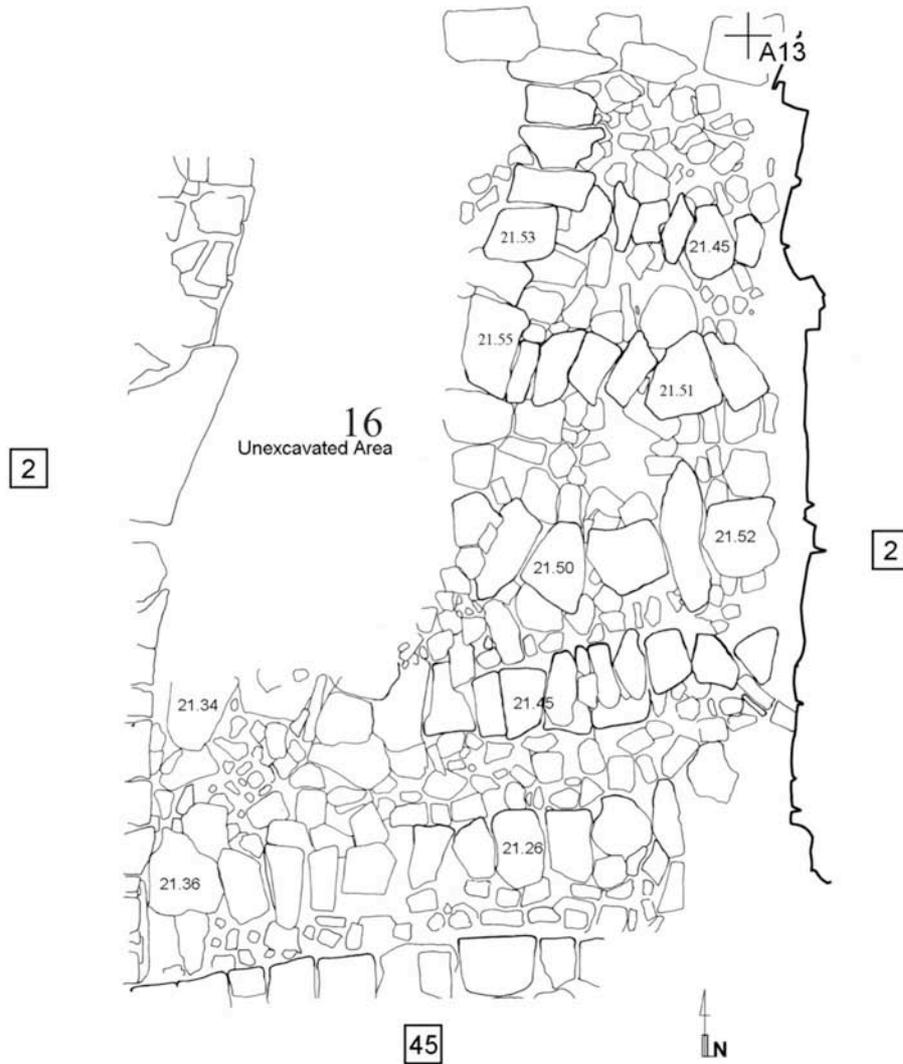
Fig. 13. Area A. Sub-floor channel system beneath Room 16, covering slabs still *in situ*. Scale 1:40.

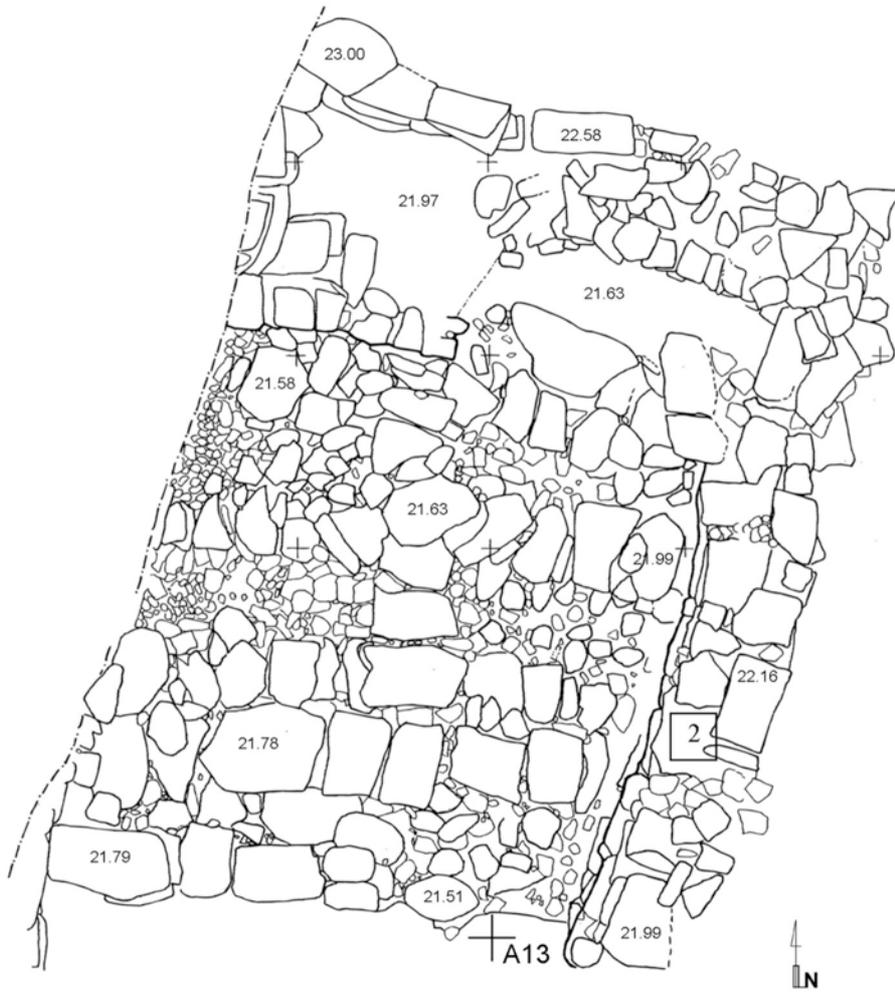
Fig. 14. Area A. Sub-floor channel system beneath Room 10, covering slabs still *in situ*. scale 1:40.

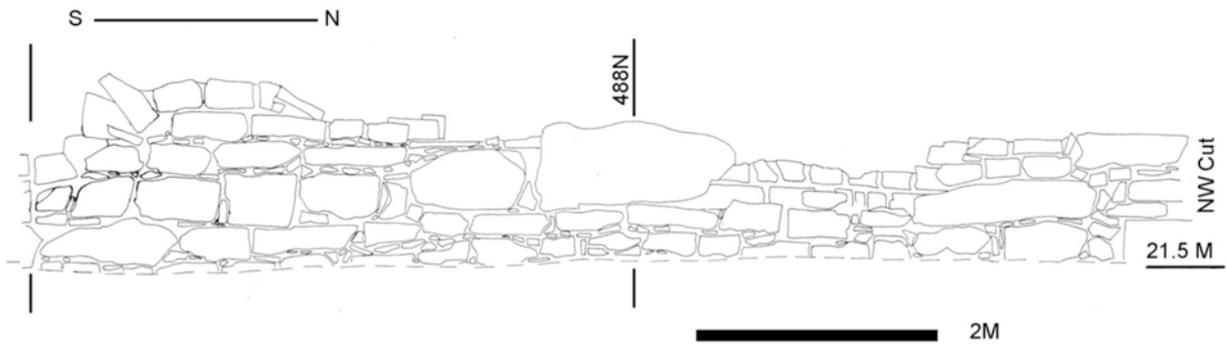
Fig. 15. Area A, Square A 12. Elevation of the eastern face of Wall [2].

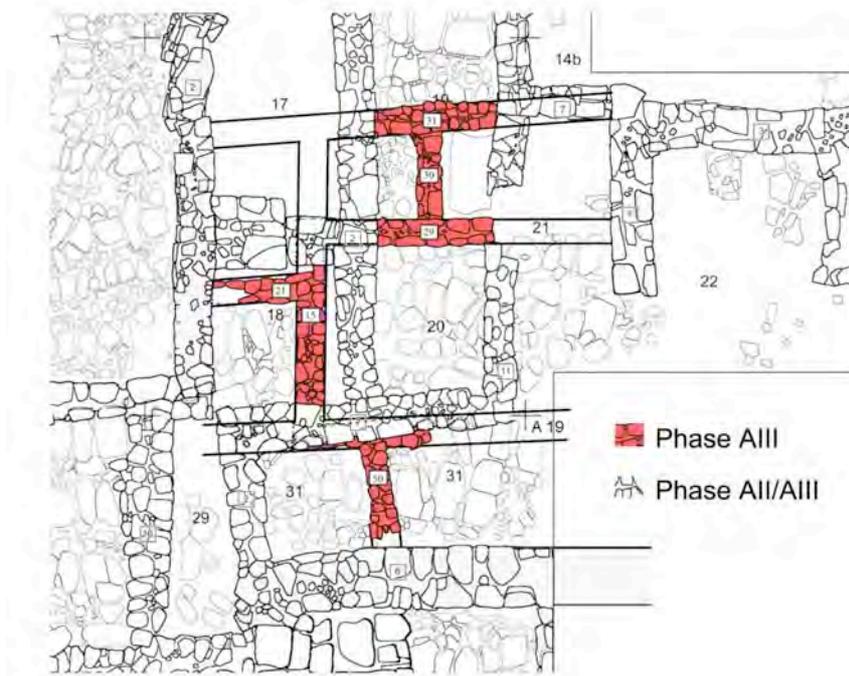
Fig. 18. Area A. Tentative reconstruction of a Phase AIII Building Unit. Scale 1:100.

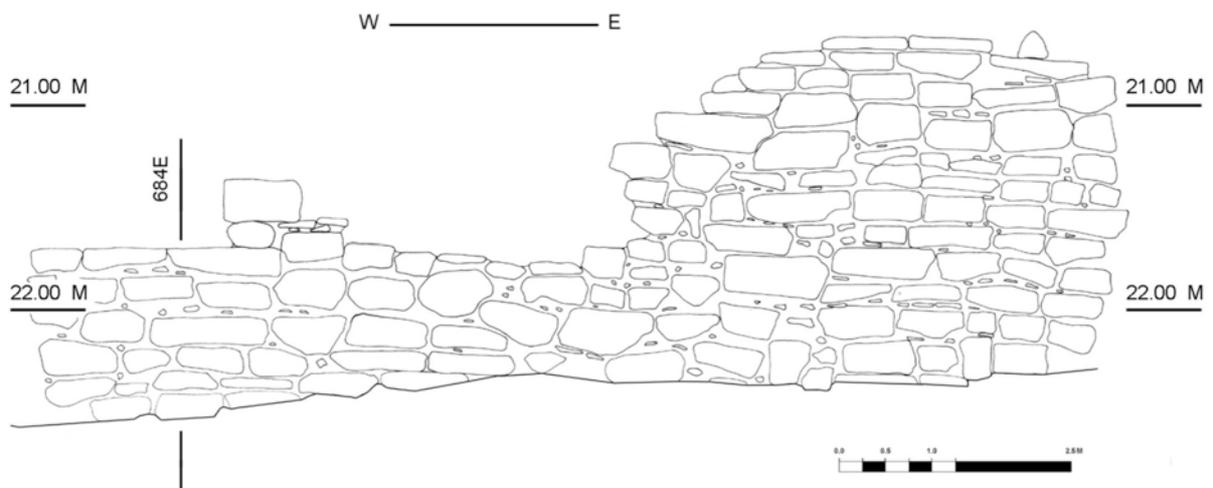
Fig. 21. Area A, Square A 22. Elevation of the southern Wall [9] of Room 28. Scale 1:40.
