# bibliotheca neolithica Asiae meridionalis et occidentalis

# BASTA II

## THE ARCHITECTURE AND STRATIGRAPHY

Hans Georg K. Gebel

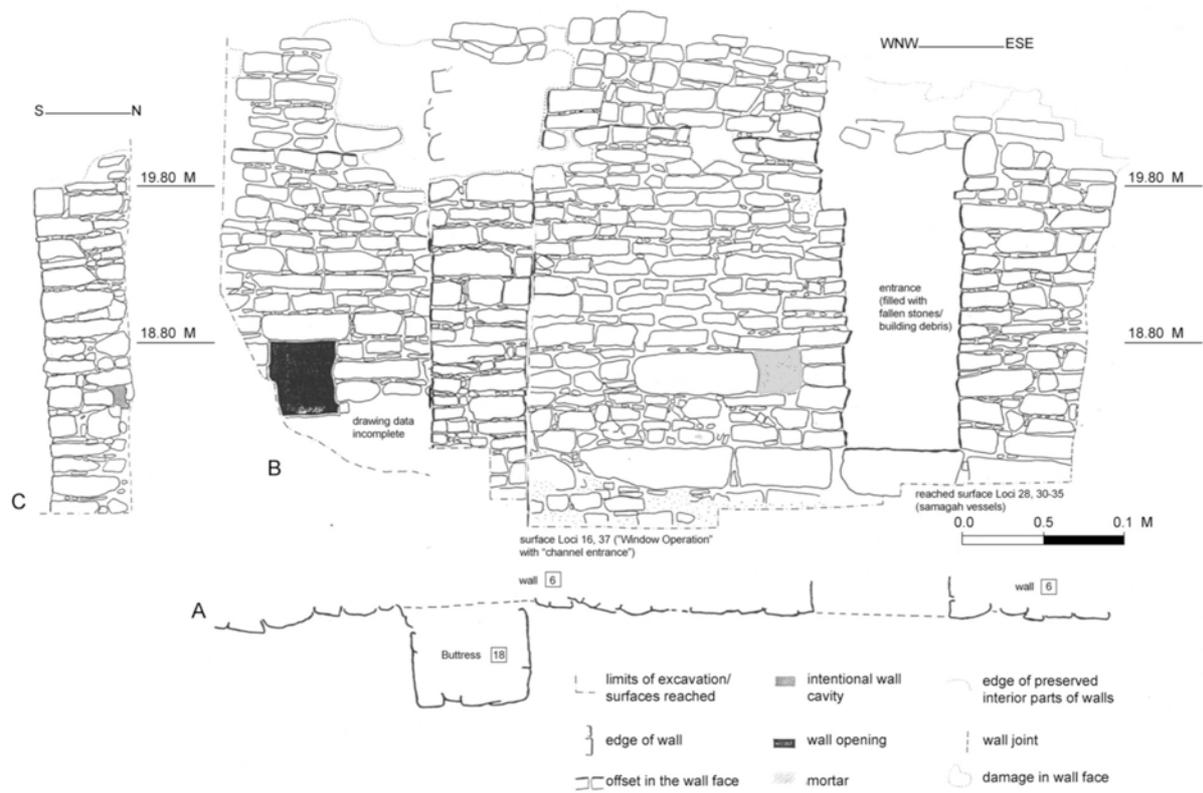
Fig. 22. Area B, Building Unit B VIII. Elevation of the northern wall of Room 2.

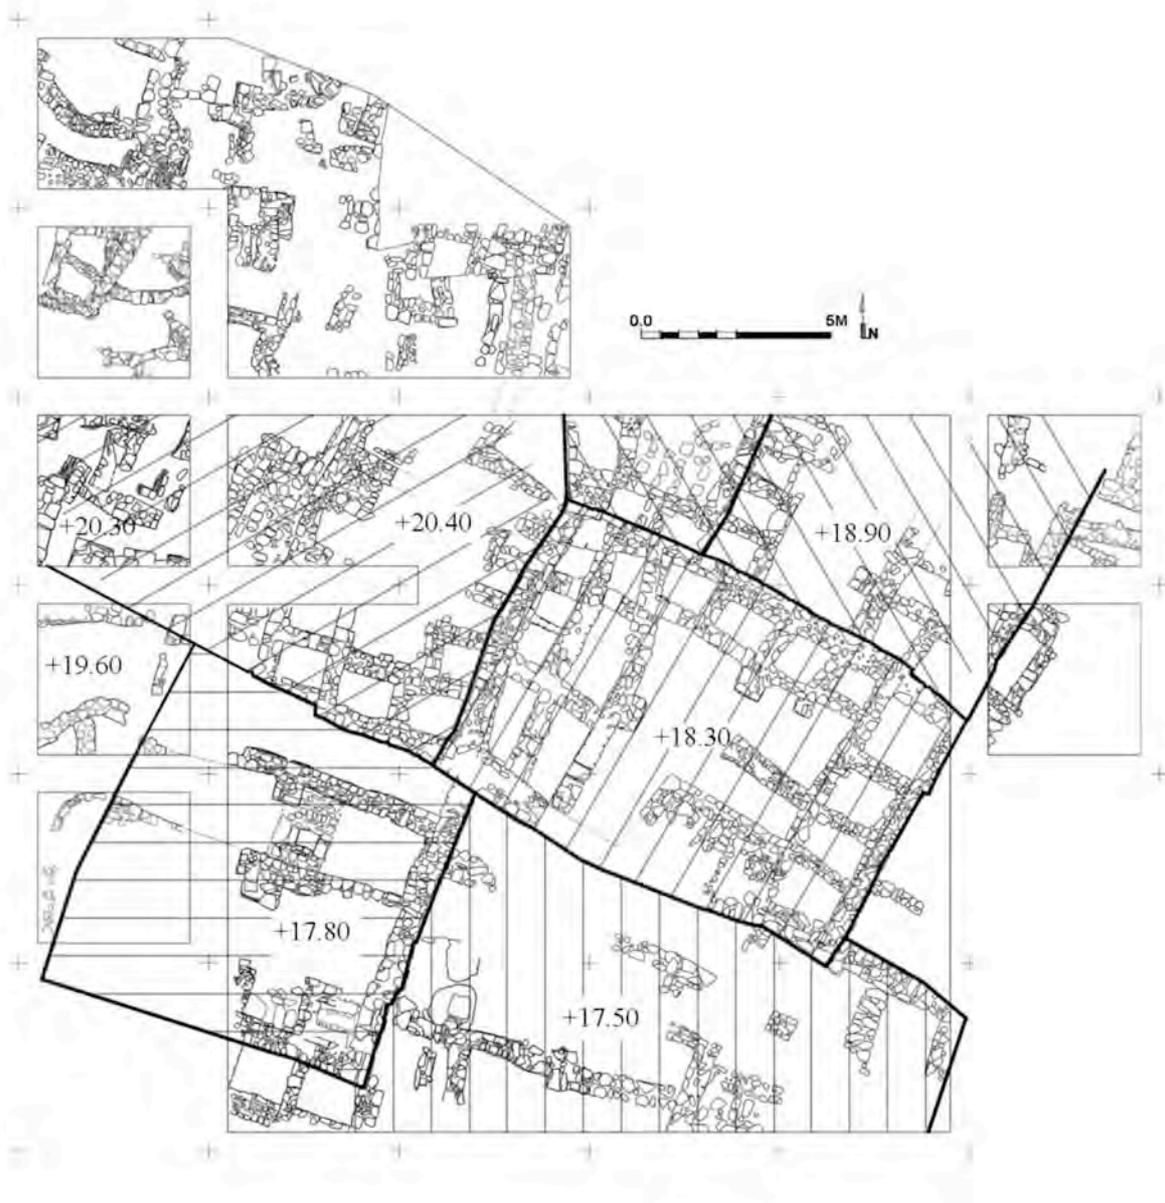
Fig. 23. Area B. Extension and elevation of the terraces of Phase BII. Scale 1:200.

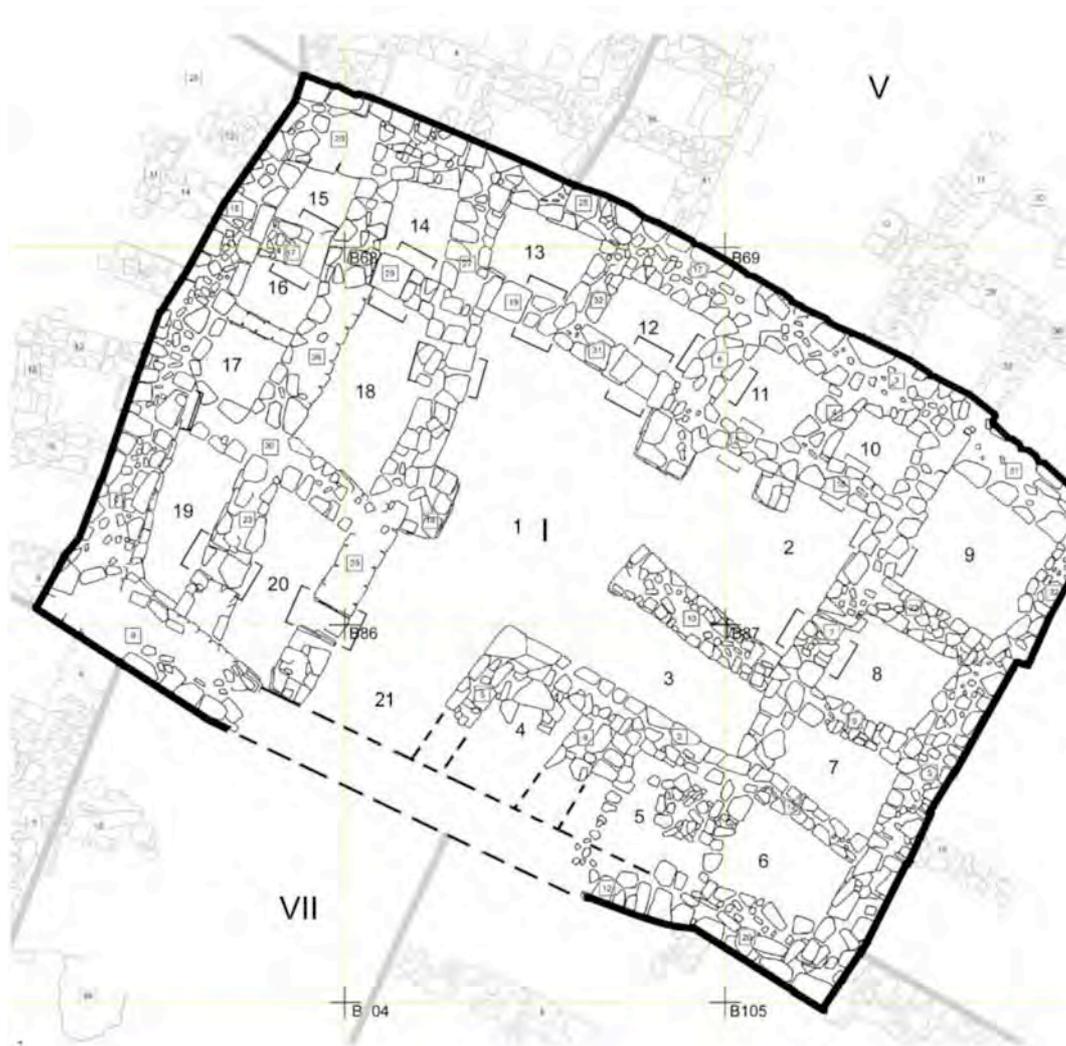
Fig. 25. Area B, Building Unit B I. Scale 1:100.

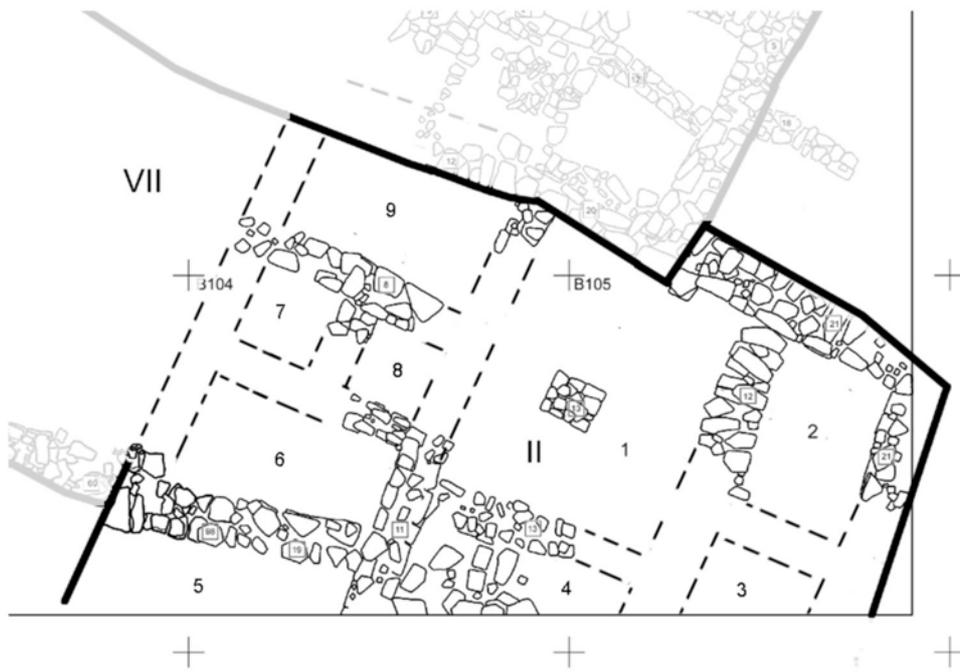
Fig. 26. Area B, Building Unit B II. Scale 1:100.

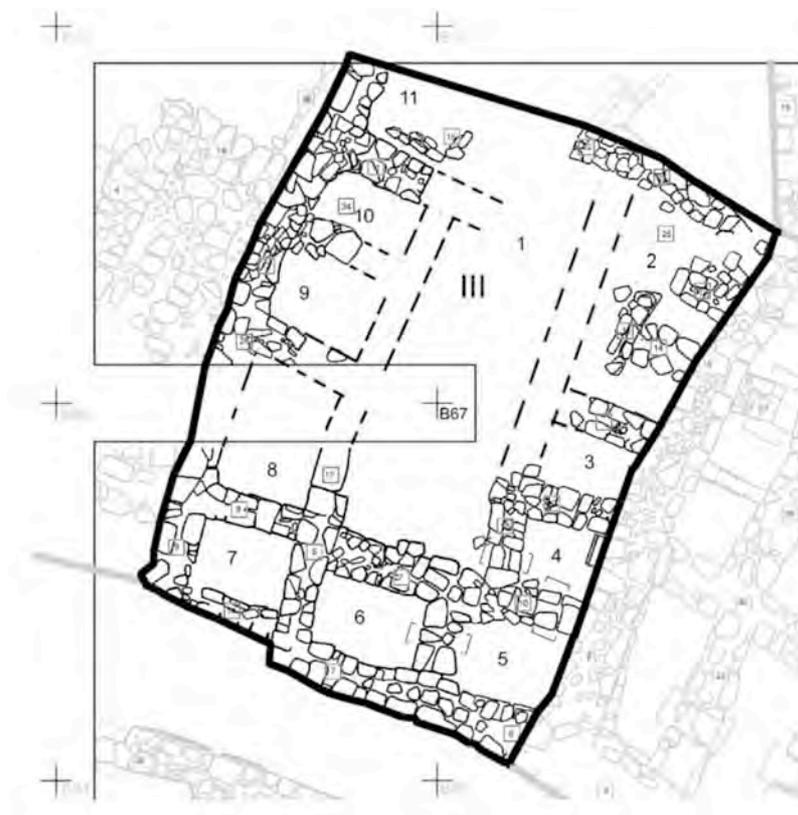
Fig. 27. Area B, Building Unit B III. Scale 1:100.

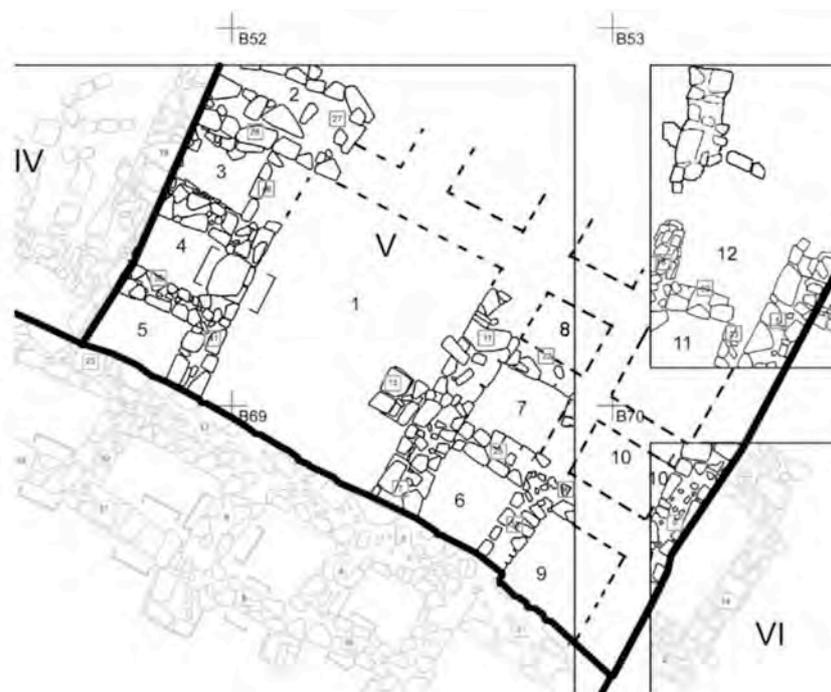
Fig. 29. Area B, Building Unit B V. Scale 1:100.

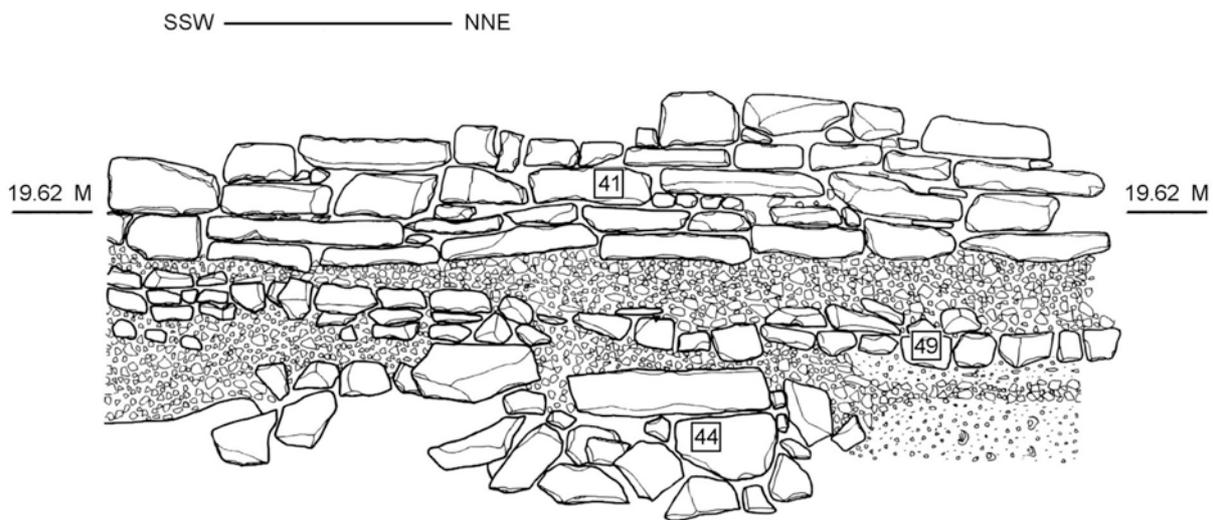
Fig. 30. Area B, Square B 52. Wall [41] with sub-structure, eastern face. Scale 1:40.

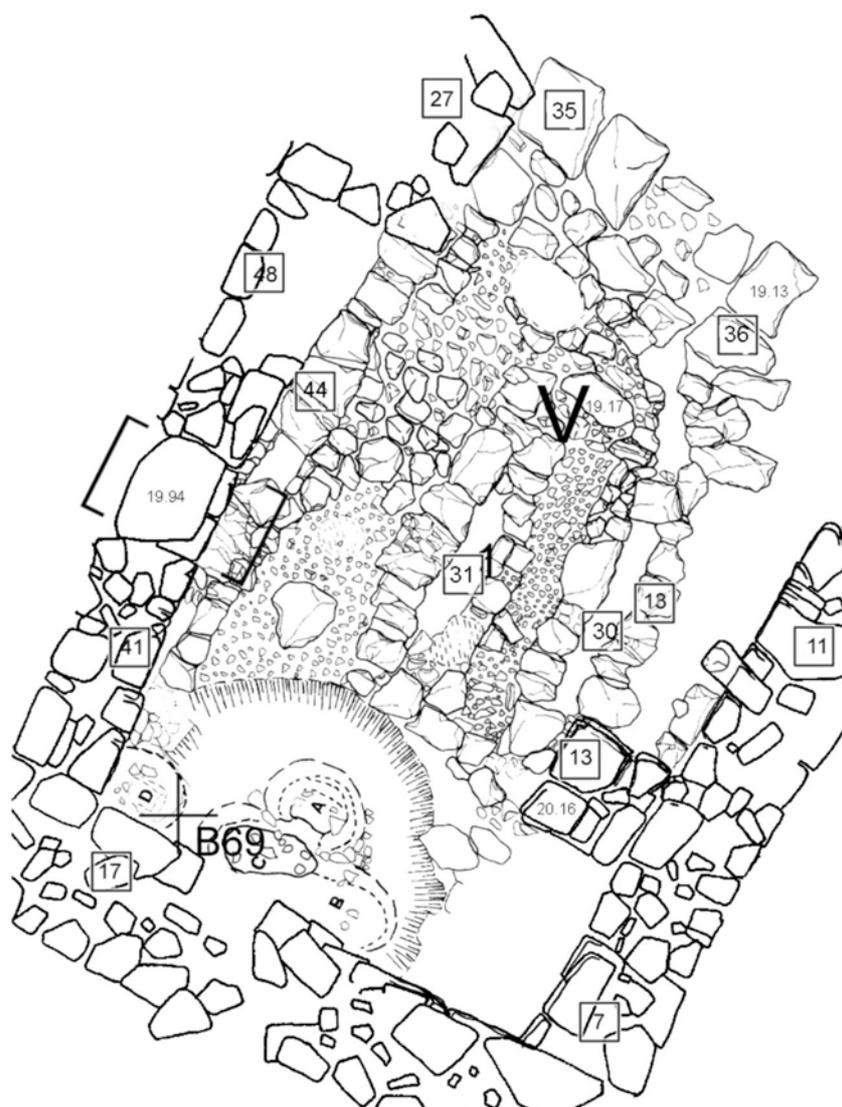
Fig. 31. Area B, Square B 52. Room B V.1. Sub-floor channel system with slabs removed. Scale 1:40.

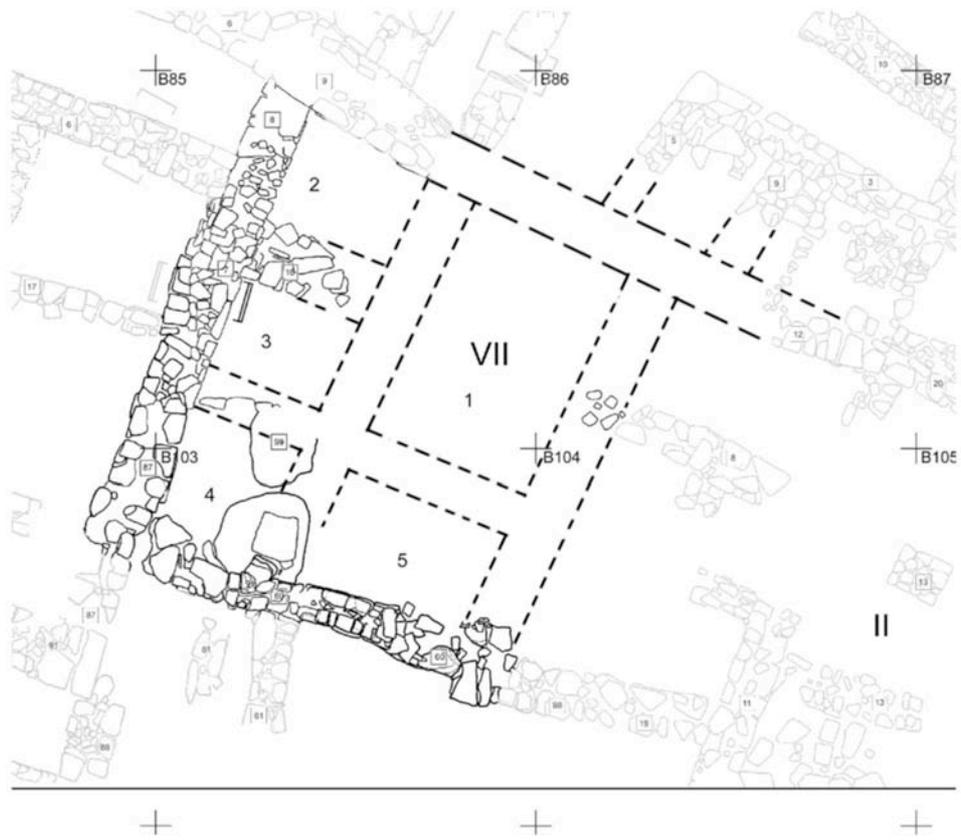
Fig. 32. Area B, Building Unit B VII. Scale 1:100.

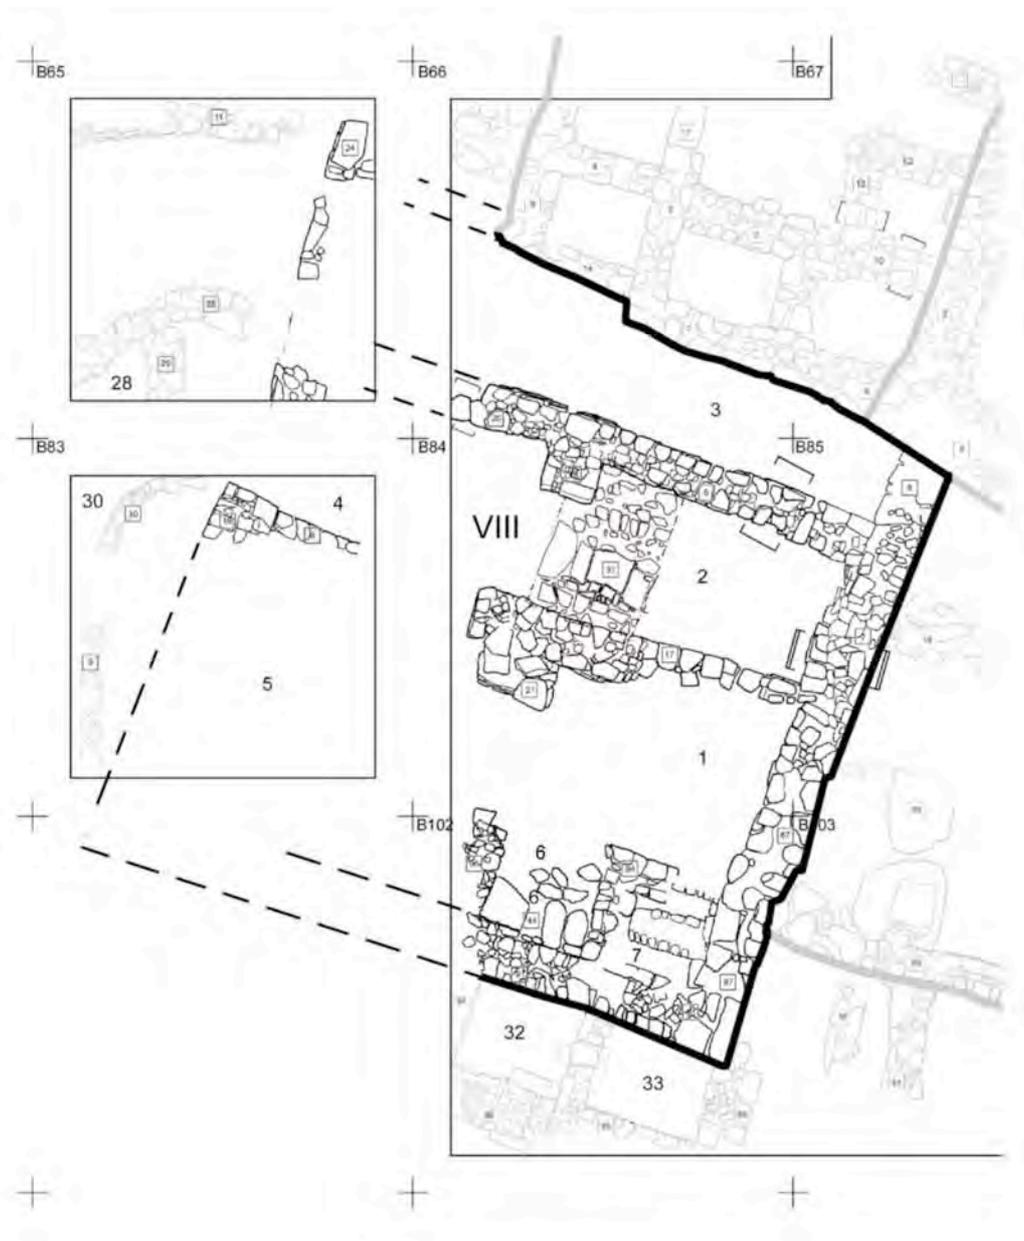
Fig. 33. Area B, Building Unit B VIII. Scale 1:100.

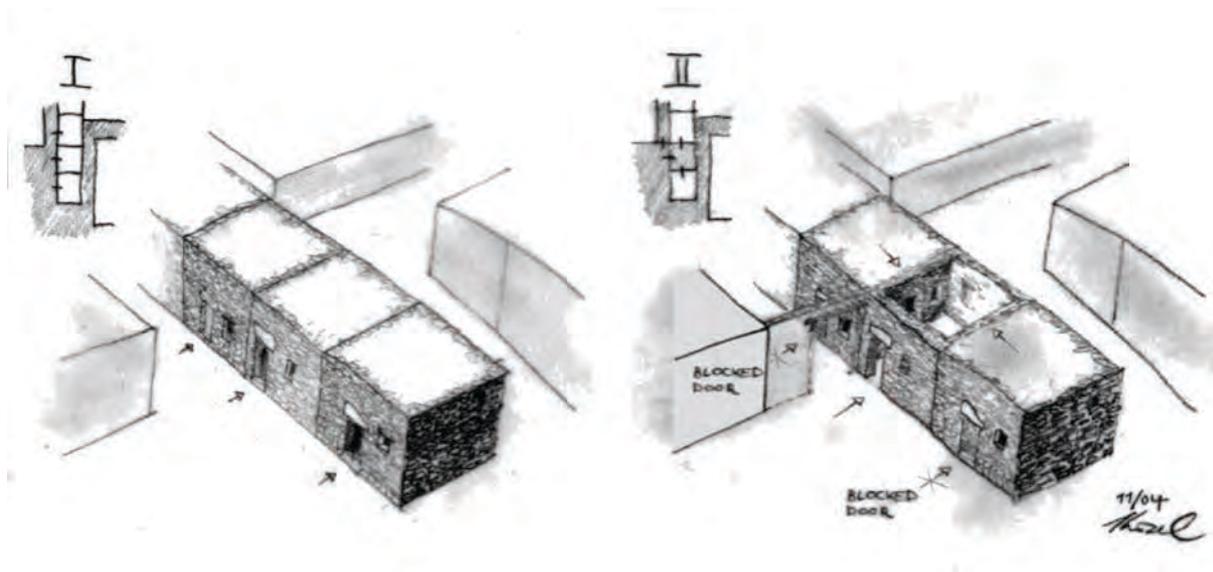
Fig. 1. Rajif Old Village, Southern Jordan. Complex building events: modification and alteration of ground plans. Three single-roomed houses (I) were transferred in a two-roomed house with a courtyard (II).

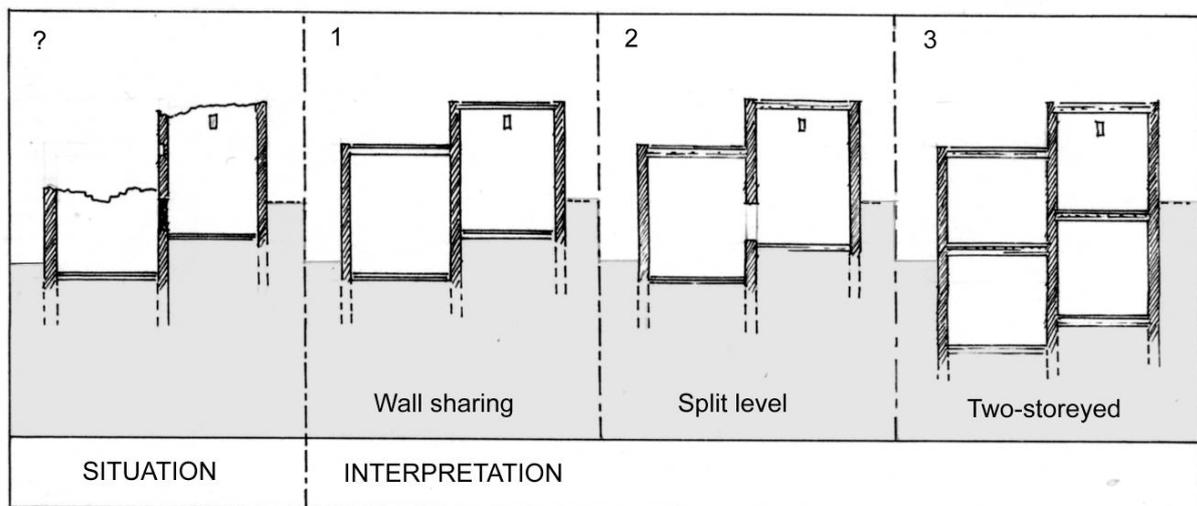
Fig. 3. Late PPNB architecture: Possible interpretations.

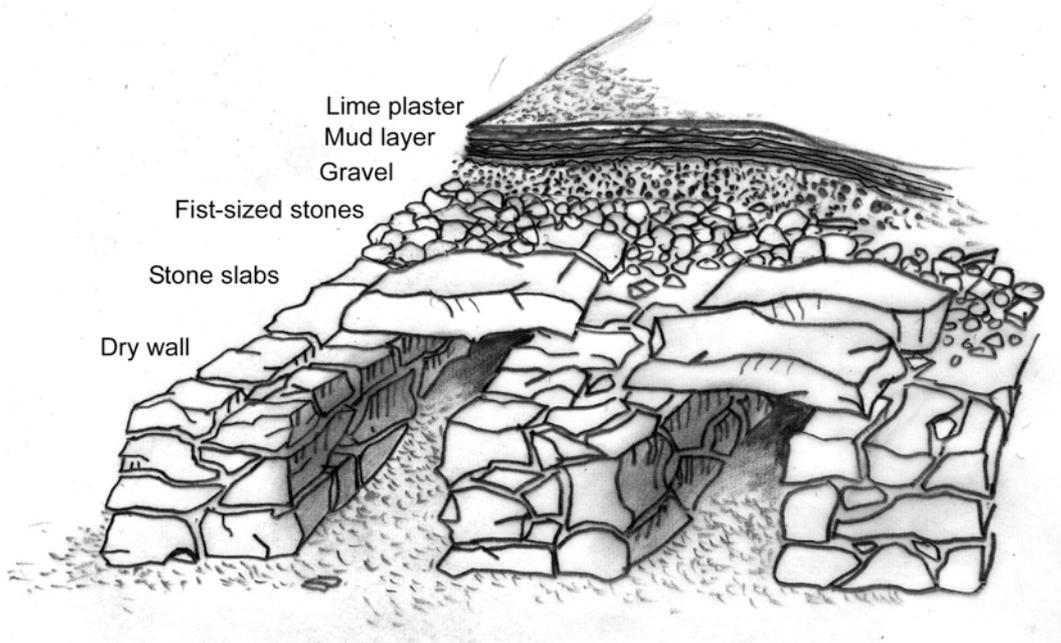
Fig. 4. Late PPNB terraces/ substructures. Construction.

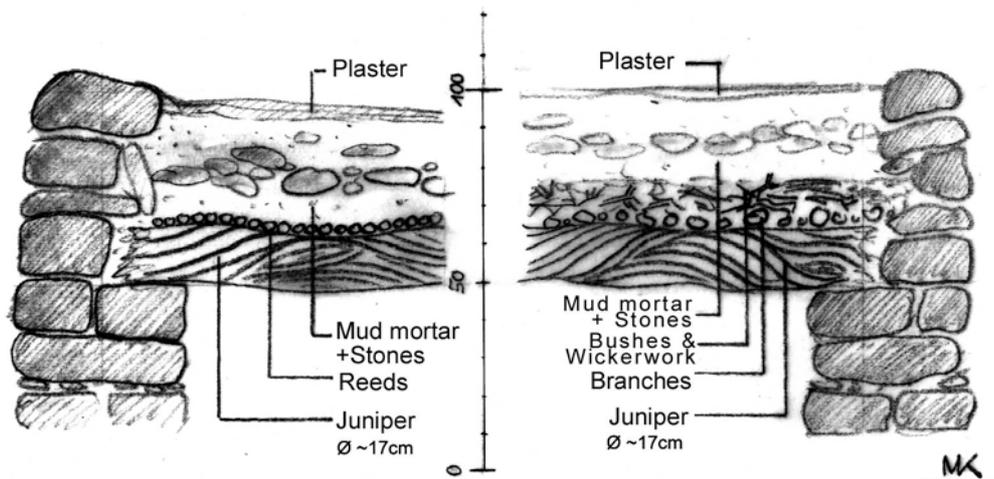
Fig. 5. Rajif and Basta Old Villages. Two traditional roof constructions similar to Late PPNB constructions.

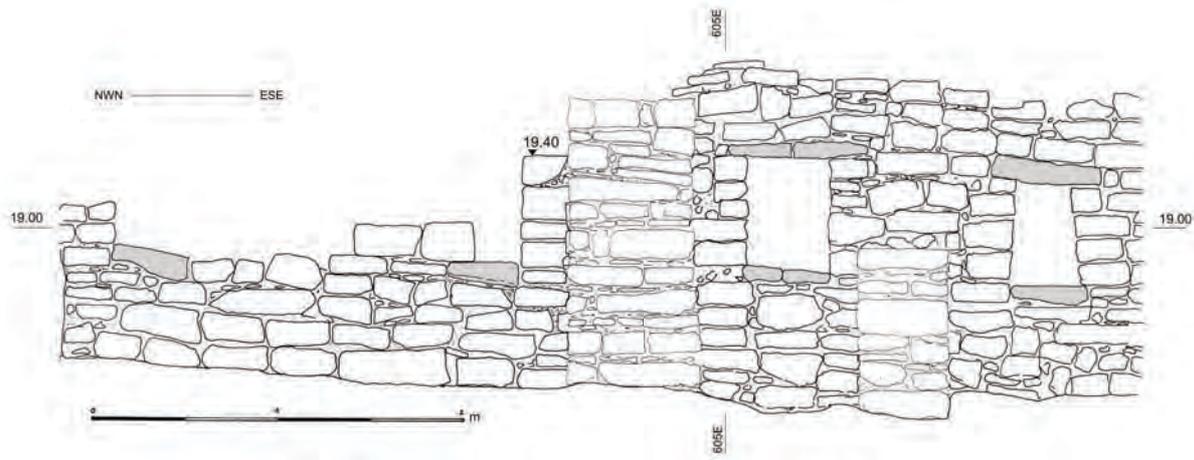
Fig. 6. Area B, Building Unit B I (Squares B 68, Locus 19 and B 69, Locus10).  
 “Window-like” wall openings with stone lintels and thresholds (shaded in grey).

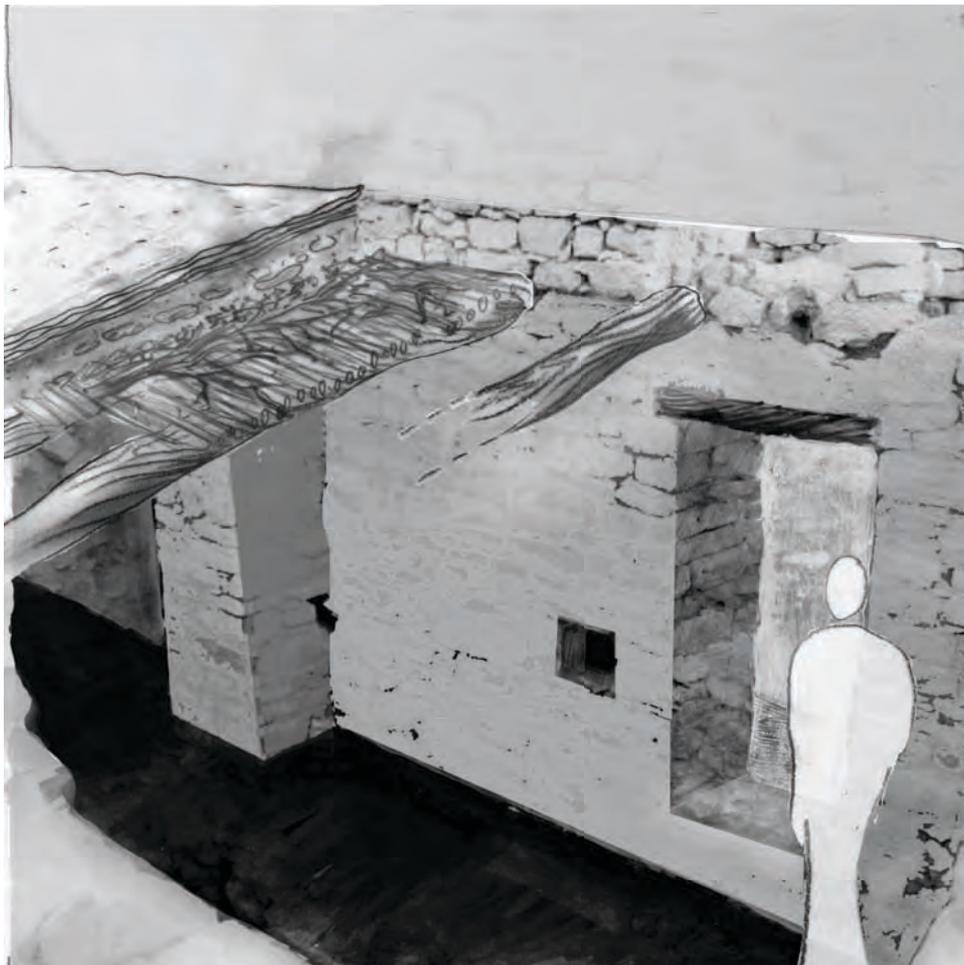
Fig. 7. Late PPNB Basta. Reconstruction of Building Unit B VIII (Square B 84).  
 Door with a wooden lintel, a niche, ceiling, and a possible second storey.

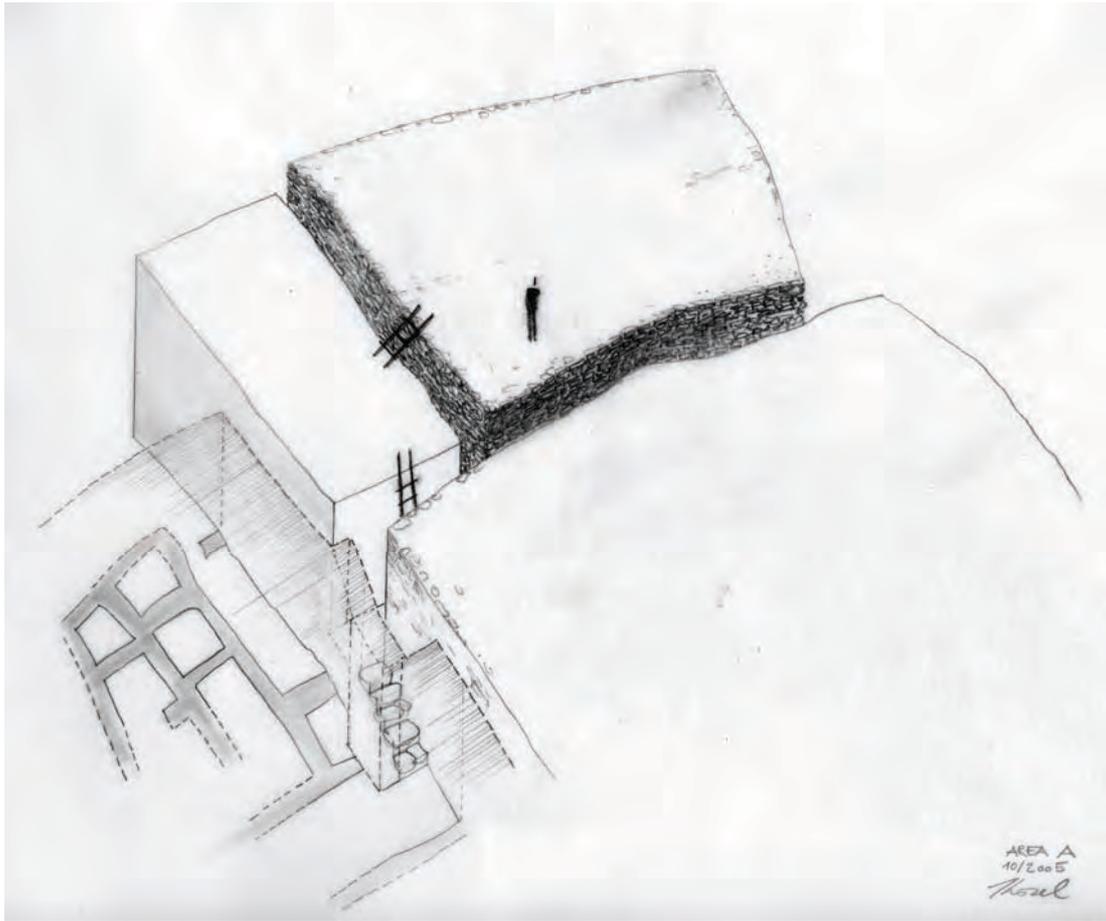
Fig. 8. Late PPNB Basta, Area A, Squares A 12-14, 17-18. Architectural reconstruction. View from SE.

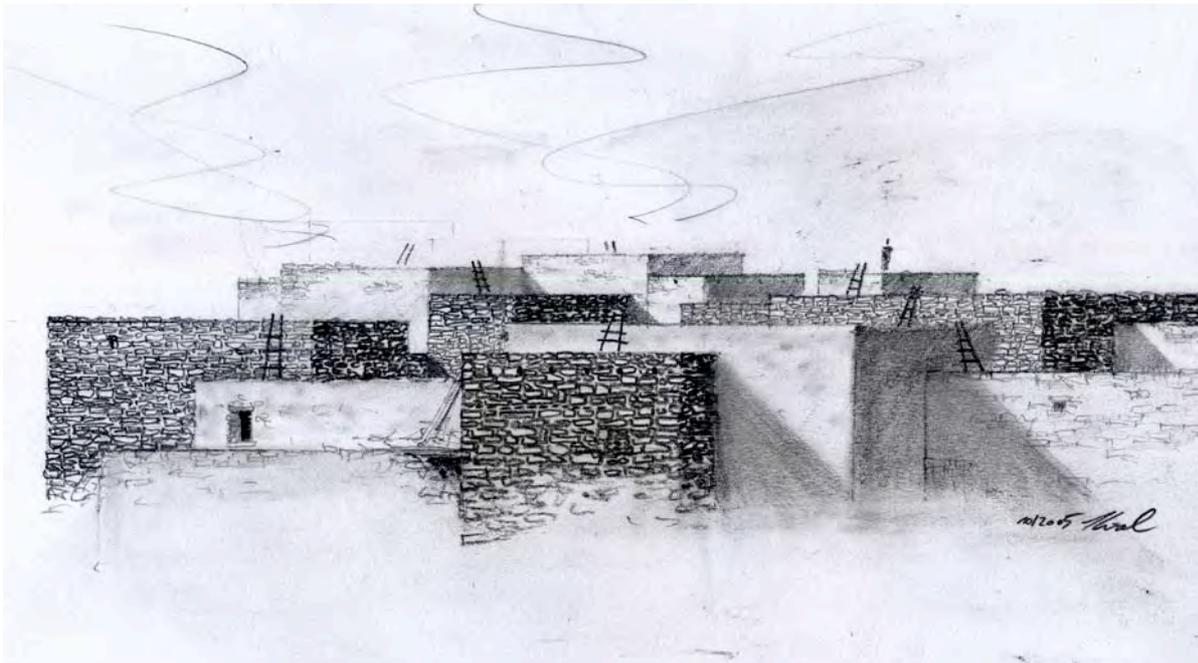
Fig. 9. Late PPNB Basta, Area B. Architectural reconstruction. Single storey buildings. View from South.

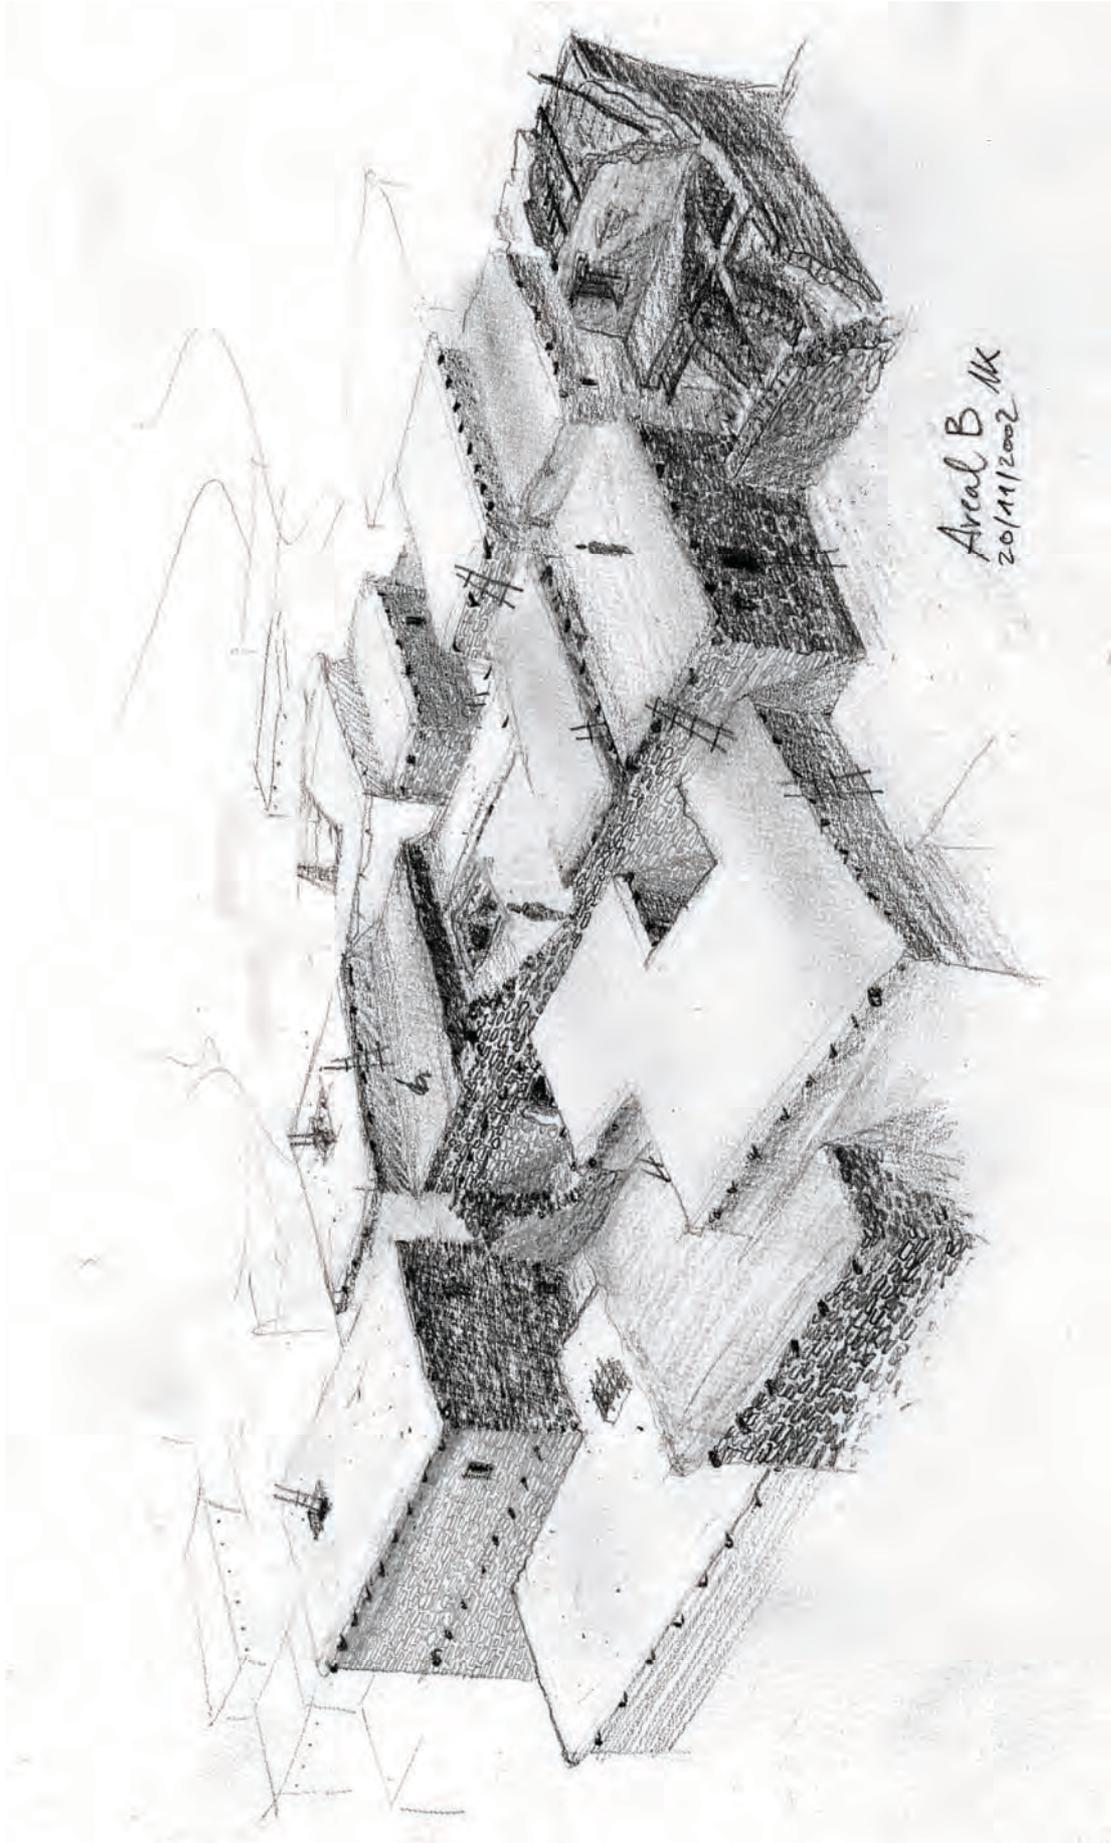
Fig. 10. Late PPNB Basta. Generalized architectural reconstruction, related to the evidence of Area B.

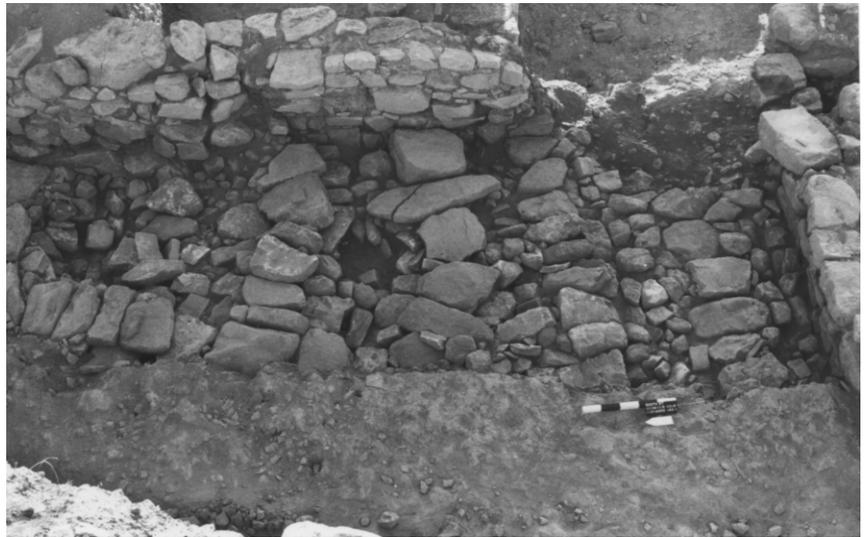
Plate 13.C. Area A, Squares A 12-13. View E. Successive stage of the excavation of Room 16: slabs removed, displaying the channel system. 1987.

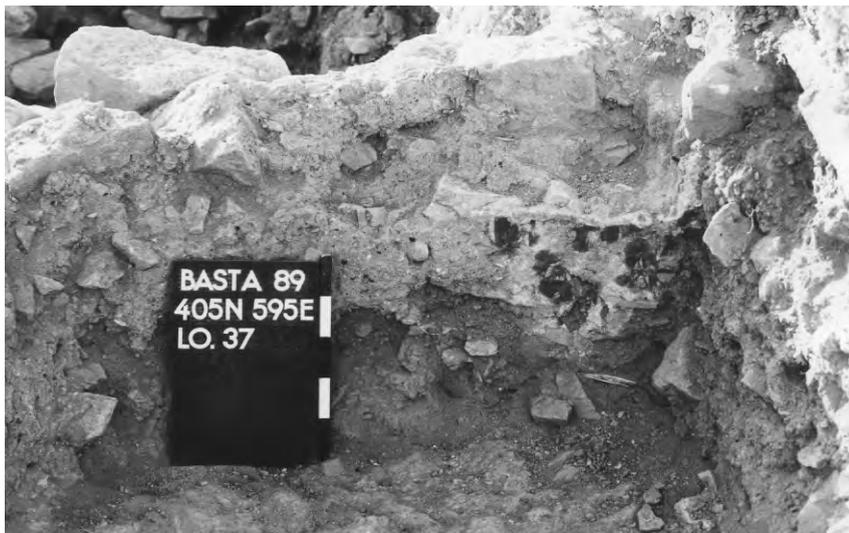
Plate 34.C. Area B, Square B 50. E-face of Wall [22] in Space 19 showing the location of the painted plaster fragments. 1989.

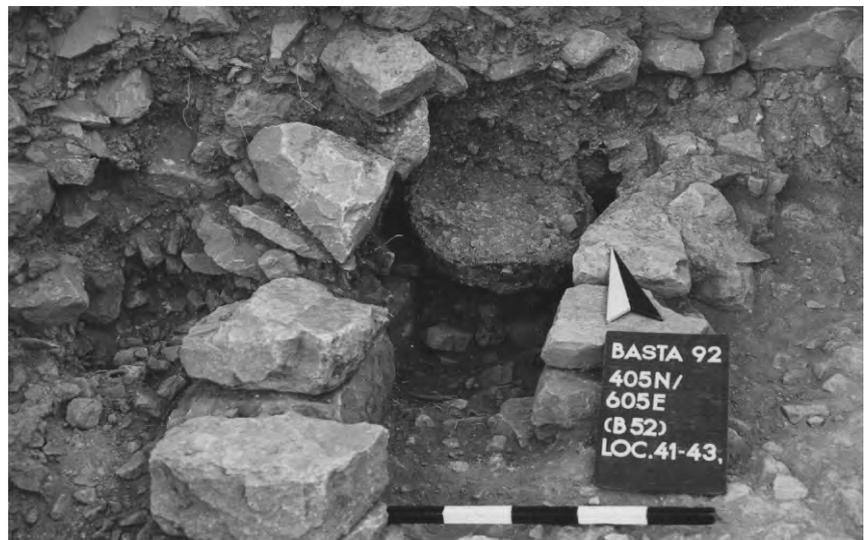
Plate 37.C. Area B, Square B 52.  
Two more *samagah* installations  
in one of the channels beneath the  
floor of Space 1 of  
Building Unit B V. 1992.

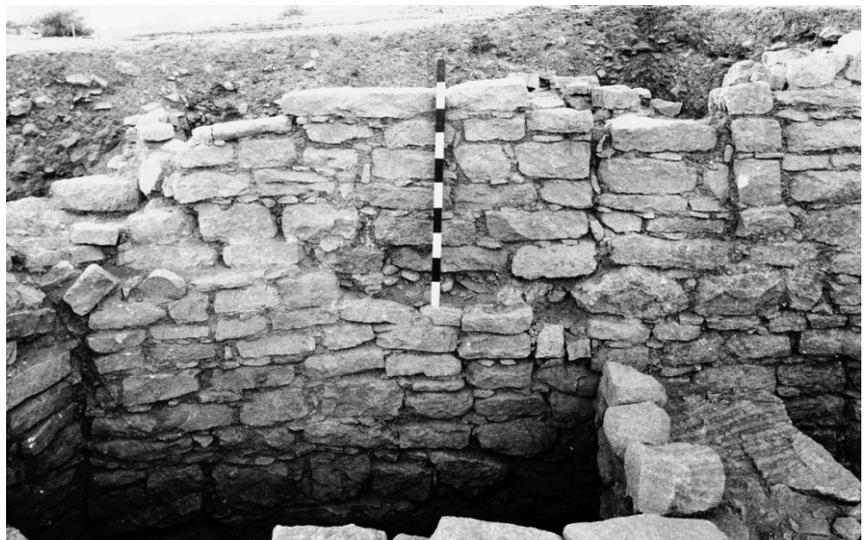
Plate 43.C. Area B, Square 68. View NE into Room 12 of Building Unit B I. Note what is left of the passage between this room and the central space, with the threshold slab *in situ*. 1987.

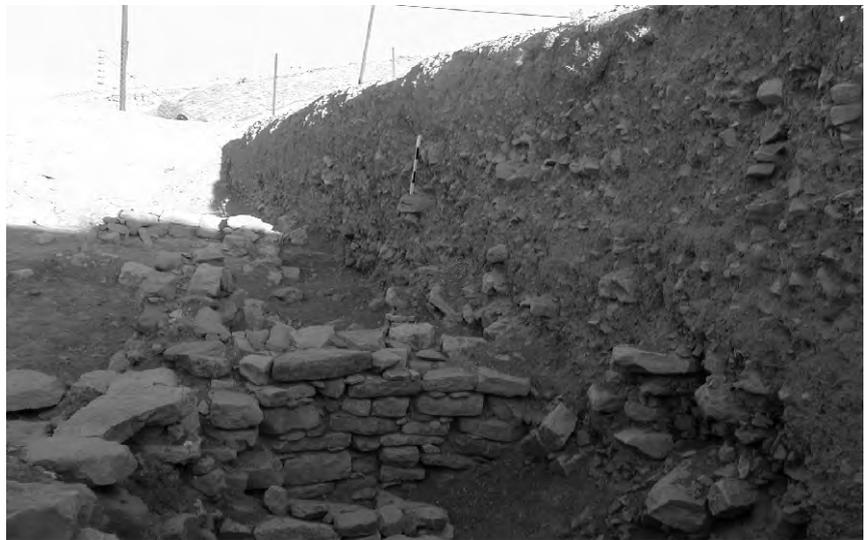
Plate 56.C. Area B, Square B 85. View WNW. Note the material of the Lower Rubble Layer passing through the wall opening in the LPPNB Wall [7].

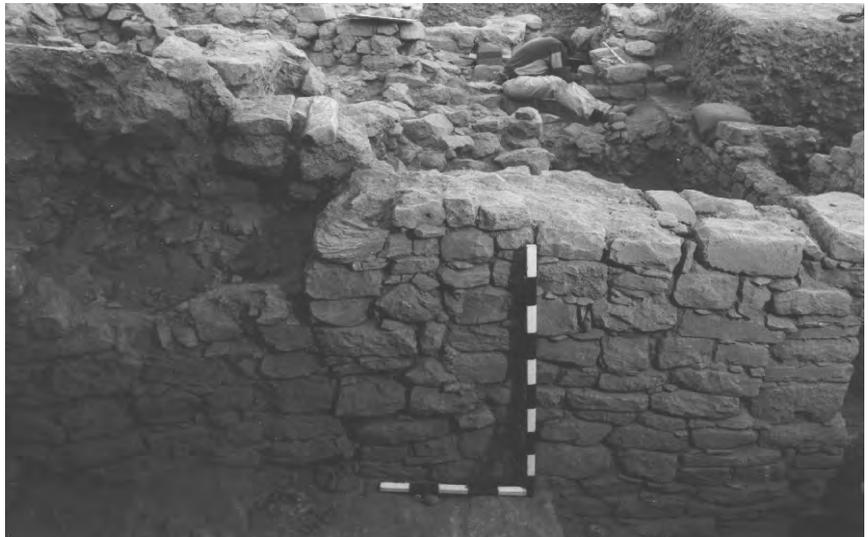
Plate 60.C. Area B, Square B 69.  
NW-elevation of Wall [7] with  
passage into Room B I,9. 1988.

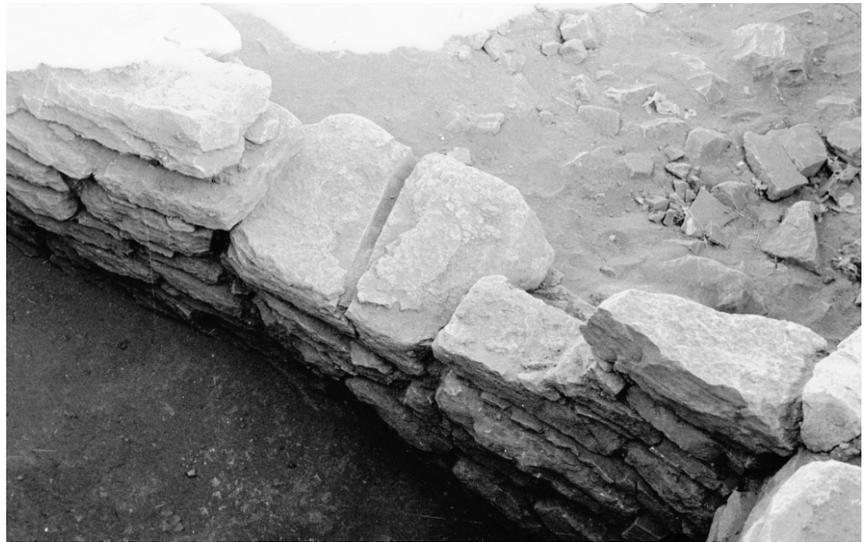
Plate 61.C. Area B. Example of a "threshold" of a passage.
